DEPARTMENT OF TRANSPORTATION

Quality Assurance and Source Inspection

Contract #: 04-0120F4Cty: SF/ALA Rte: 80 PM: 13.2/13.9File #: 69.28**WELDING INSPECTION REPORT****Resident Engineer:** Siegenthaler, Peter**Address:** 333 Burma Road**City:** Oakland, CA 94607**Report No:** WIR-024097**Date Inspected:** 24-May-2011**Project Name:** SAS Superstructure**OSM Arrival Time:** 700**Prime Contractor:** American Bridge/Fluor Enterprises, a JV**OSM Departure Time:** 1900**Contractor:** Zhenhua Port Machinery Company, Ltd (ZPMC), Changxing Island **Location:** Shanghai, China**CWI Name:** Zhu Zhong Hai**CWI Present:** Yes No**Inspected CWI report:** Yes No N/A**Rod Oven in Use:** Yes No N/A**Electrode to specification:** Yes No N/A**Weld Procedures Followed:** Yes No N/A**Qualified Welders:** Yes No N/A**Verified Joint Fit-up:** Yes No N/A**Approved Drawings:** Yes No N/A**Approved WPS:** Yes No N/A**Delayed / Cancelled:** Yes No N/A**Bridge No:** 34-0006**Component:** Orthotropic Box Girder (OBG)**Summary of Items Observed:**

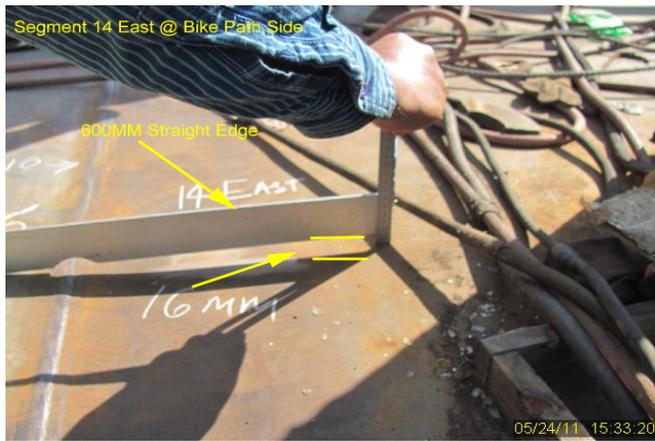
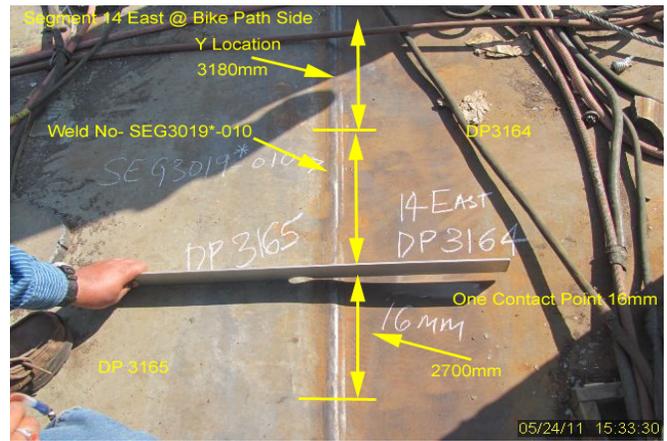
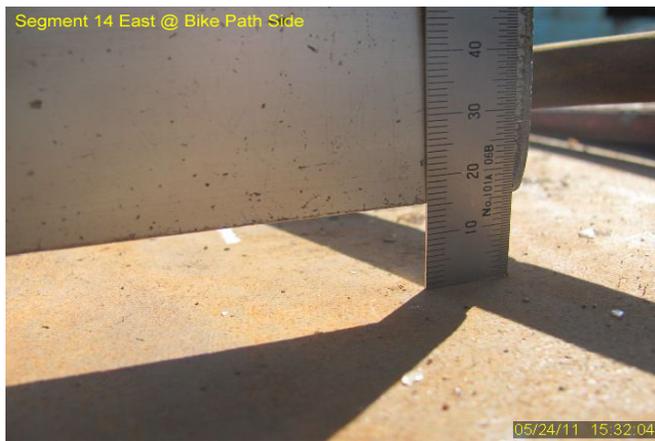
Segment 14 East

During random in process observations of the Trial Assembly Yard of Deck plate 14East, this Caltrans Quality Assurance Inspector observed the following issue:

- The distortion measuring approximately 16mm from the Deck plate 14 East.
 - The weld joint identified as SEG3019*-010.
 - The Deck Plate is identified as 14 East: DP3164 and DP3165 (SPCM)
 - The distortion was measured using a 600mm straight edge.
 - Plate is located in the Bike Path side of Trial Assembly Yard.
- Report was forwarded to Caltrans QA Lead.
For further information, please reference the attached pictures.
