**DEPARTMENT OF TRANSPORTATION**

Contract #: 04-0120F4Cty: SF/ALA Rte: 80 PM: 13.2/13.9File #: 69.28**WELDING INSPECTION REPORT****Resident Engineer:** Siegenthaler, Peter**Address:** 333 Burma Road**City:** Oakland, CA 94607**Report No:** WIR-024114**Date Inspected:** 15-May-2011**Project Name:** SAS Superstructure**OSM Arrival Time:** 1500**Prime Contractor:** American Bridge/Fluor Enterprises, a JV**OSM Departure Time:** 300**Contractor:** Zhenhua Port Machinery Company, Ltd (ZPMC), Changxing Island **Location:** Shanghai, China**CWI Name:** See Below**CWI Present:** Yes No**Inspected CWI report:** Yes No N/A**Rod Oven in Use:** Yes No N/A**Electrode to specification:** Yes No N/A**Weld Procedures Followed:** Yes No N/A**Qualified Welders:** Yes No N/A**Verified Joint Fit-up:** Yes No N/A**Approved Drawings:** Yes No N/A**Approved WPS:** Yes No N/A**Delayed / Cancelled:** Yes No N/A**Bridge No:** 34-0006**Component:** OBG**Summary of Items Observed:**

# WELDING INSPECTION REPORT

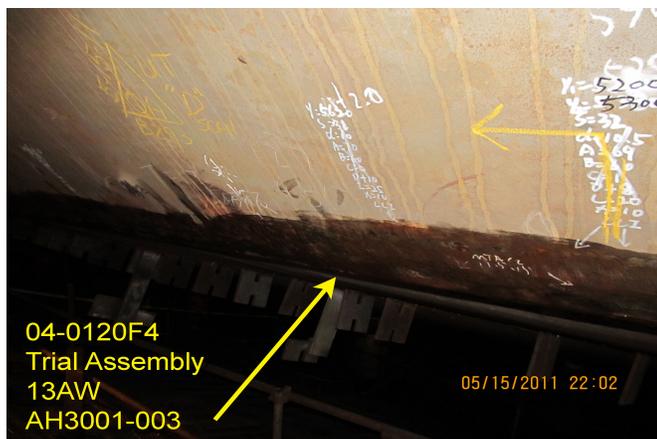
At the time of the verification it was noted that the above component appeared to be within compliance of the contract documents. See Caltrans Ultrasonic Test Report (TL6027), dated 05-15-2011 for additional information.

The following digital picture illustrates weld AH3001-003.
