DEPARTMENT OF TRANSPORTATION

Contract #: 04-0120F4Cty: SF/ALA Rte: 80 PM: 13.2/13.9File #: 69.28**WELDING INSPECTION REPORT****Resident Engineer:** Siegenthaler, Peter**Address:** 333 Burma Road**City:** Oakland, CA 94607**Report No:** WIR-024137**Date Inspected:** 04-Jun-2011**Project Name:** SAS Superstructure**OSM Arrival Time:** 700**Prime Contractor:** American Bridge/Fluor Enterprises, a JV**OSM Departure Time:** 1900**Contractor:** Zhenhua Port Machinery Company, Ltd (ZPMC), Changxing Island **Location:** Shanghai, China

Segment 13AW Bearing Block Assembly (for Anchor Bolt Seat) at OBG Trial Assembly

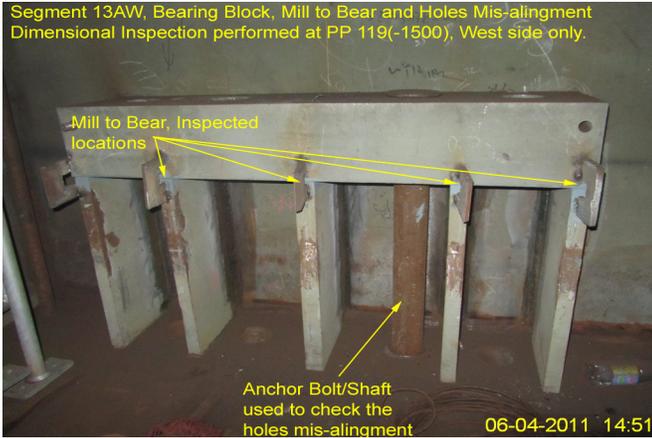
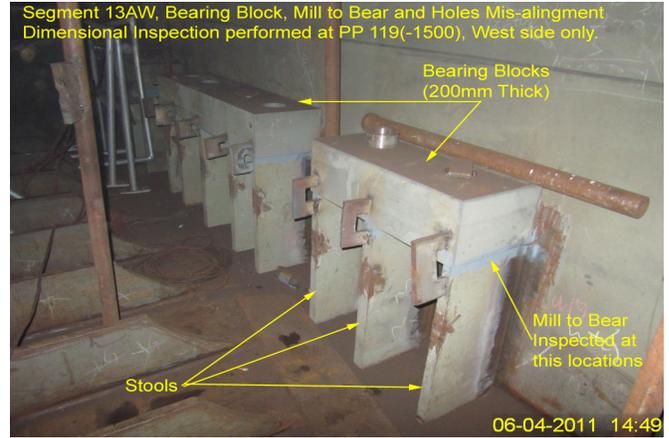
This QA Inspector performed Dimension Control Inspection on the Bearing Block Assembly (for Anchor Bolt Seat) at OBG Trial Assembly for Segment 13AW at the following locations along with ABF QA Mr. Wang at W3 locations. The Inspection was performed against the Notification # 09358 dated June 04, 2011.

Bearing Blocks are installed at PP 119 (-1500mm), Total 4 locations at West side of the Floor Beam.

Dimension inspection was performed after passing the anchor rod at between the holes of Bearing Block to Bottom Plate and recorded the various measurements as following.
