Contract #: 04-0120F4Cty: SF/ALA Rte: 80 PM: 13.2/13.9File #: 69.28**WELDING INSPECTION REPORT****Resident Engineer:** Siegenthaler, Peter**Address:** 333 Burma Road**City:** Oakland, CA 94607**Report No:** WIR-024217**Date Inspected:** 31-May-2011**Project Name:** SAS Superstructure**OSM Arrival Time:** 1900**Prime Contractor:** American Bridge/Fluor Enterprises, a JV**OSM Departure Time:** 700**Contractor:** Zhenhua Port Machinery Company, Ltd (ZPMC), Changxing Island **Location:** Shanghai, China**CWI Name:** See below**CWI Present:** Yes No**Inspected CWI report:** Yes No N/A**Rod Oven in Use:** Yes No N/A**Electrode to specification:** Yes No N/A**Weld Procedures Followed:** Yes No N/A**Qualified Welders:** Yes No N/A**Verified Joint Fit-up:** Yes No N/A**Approved Drawings:** Yes No N/A**Approved WPS:** Yes No N/A**Delayed / Cancelled:** Yes No N/A**Bridge No:** 34-0006**Component:** OBG**Summary of Items Observed:**

OBG Trial Assembly

Segment 13AE PP117.4 to 118 on the CB side

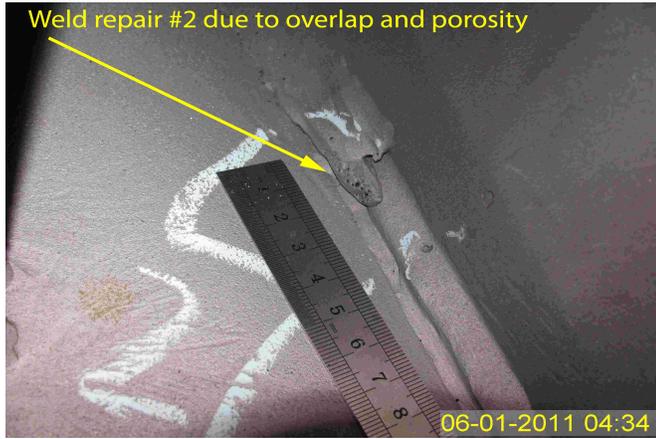
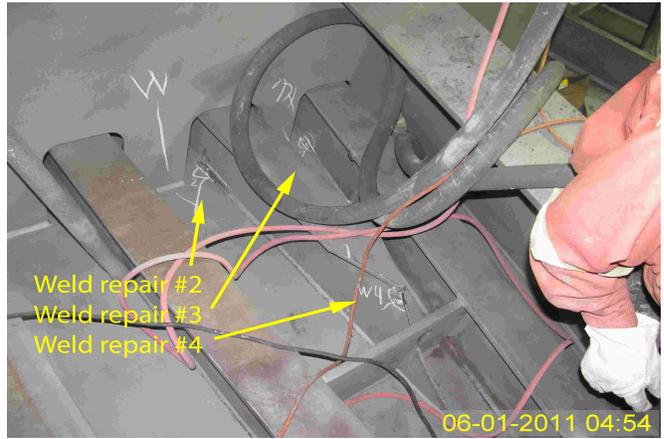
1. Porosity, 400 mm from SEG3013Q weld 205 @ PP118. Top edge of bottom plate rib has porosity
2. Porosity and overlap, second rib up from LD, @ PP117.5 Rib weld to side plate has porosity and overlap.
3. Overlap top and bottom toe of weld, @ PP117.5. AQ11 rib weld to side plate weld
4. End of tapered end of the first rib AQ11 from LD. MT rejection of weld repair area, top end of taper.
5. Incomplete fusion (hole), weld 192. 50mm from @PP117.5 (toward open end)
6. Base metal gouge in side plate located between edge plate and weld 204, SEG3013W view S3E, 250 mm from floor beam at PP117.5.

7. Base metal temporary weld removal areas, holed flange plate approximately two meters above bottom plate above view SEG3013S AR2.
