DEPARTMENT OF TRANSPORTATION

Contract #: 04-0120F4Cty: SF/ALA Rte: 80 PM: 13.2/13.9File #: 1.28**WELDING INSPECTION REPORT****Resident Engineer:** Siegenthaler, Peter**Address:** 333 Burma Road**City:** Oakland, CA 94607**Report No:** WIR-024239**Date Inspected:** 01-Jun-2011**Project Name:** SAS Superstructure**OSM Arrival Time:** 700**Prime Contractor:** American Bridge/Fluor Enterprises, a JV**OSM Departure Time:** 1730**Contractor:** American Bridge/Fluor Enterprises, a JV**Location:** Job Site**CWI Name:** See Report Below**CWI Present:** Yes No**Inspected CWI report:** Yes No N/A**Rod Oven in Use:** Yes No N/A**Electrode to specification:** Yes No N/A**Weld Procedures Followed:** Yes No N/A**Qualified Welders:** Yes No N/A**Verified Joint Fit-up:** Yes No N/A**Approved Drawings:** Yes No N/A**Approved WPS:** Yes No N/A**Delayed / Cancelled:** Yes No N/A**Bridge No:** 34-0006**Component:** Orthotropic Box Girders**Summary of Items Observed:**

WELDING INSPECTION REPORT

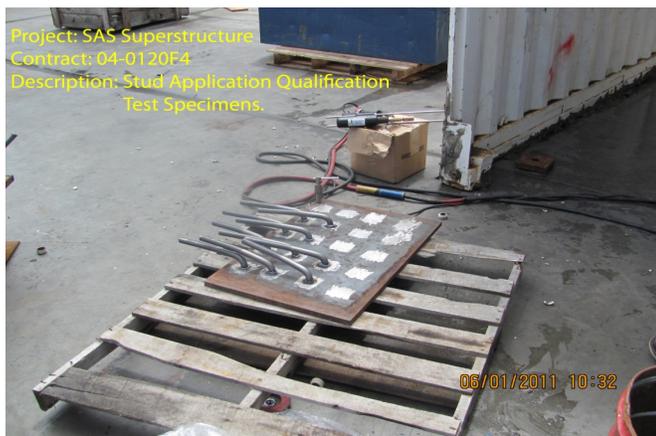
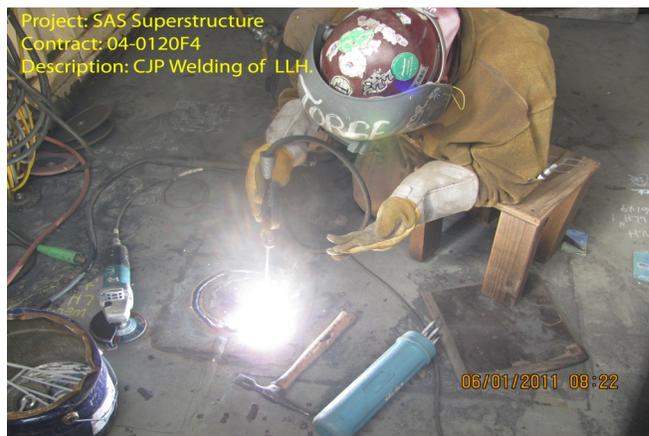
The digital photographs below illustrate some of the work observed during this scheduled shift.
