DEPARTMENT OF TRANSPORTATION

Quality Assurance and Source Inspection

Contract #: 04-0120F4Cty: SF/ALA Rte: 80 PM: 13.2/13.9File #: 1.28**WELDING INSPECTION REPORT****Resident Engineer:** Siegenthaler, Peter**Address:** 333 Burma Road**City:** Oakland, CA 94607**Report No:** WIR-024244**Date Inspected:** 04-Jun-2011**Project Name:** SAS Superstructure**OSM Arrival Time:** 700**Prime Contractor:** American Bridge/Fluor Enterprises, a JV**OSM Departure Time:** 1330**Contractor:** American Bridge/Fluor Enterprises, a JV**Location:** Job Site**CWI Name:** See Report Below**CWI Present:** Yes No**Inspected CWI report:** Yes No N/A**Rod Oven in Use:** Yes No N/A**Electrode to specification:** Yes No N/A**Weld Procedures Followed:** Yes No N/A**Qualified Welders:** Yes No N/A**Verified Joint Fit-up:** Yes No N/A**Approved Drawings:** Yes No N/A**Approved WPS:** Yes No N/A**Delayed / Cancelled:** Yes No N/A**Bridge No:** 34-0006**Component:** Orthotropic Box Girders**Summary of Items Observed:**

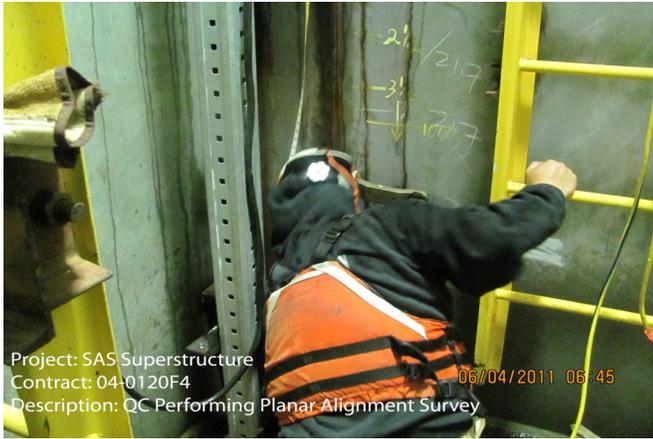
The QAI observed and verified the QC inspectors, Jesse Cayabyab and Pat Swain, performed the planar alignment survey of the shear plate butt joint identified W-044. There were approximately 3 areas that appeared to exceed the contract specification tolerances and were noted by the QC personnel on the ESW JOINT GAP and OFFSET MAP. The root opening was also measured and verified by the QAI as 21 mm to 24 mm.
