DEPARTMENT OF TRANSPORTATION

Contract #: 04-0120F4Cty: SF/ALA Rte: 80 PM: 13.2/13.9File #: 1.28**WELDING INSPECTION REPORT****Resident Engineer:** Siegenthaler, Peter**Address:** 333 Burma Road**City:** Oakland, CA 94607**Report No:** WIR-024266**Date Inspected:** 03-Jun-2011**Project Name:** SAS Superstructure**OSM Arrival Time:** 700**Prime Contractor:** American Bridge/Fluor Enterprises, a JV**OSM Departure Time:** 1530**Contractor:** American Bridge/Fluor Enterprises, a JV**Location:** Jobsite

Bridge No: 34-0006**Component:** SAS OBG**Summary of Items Observed:**

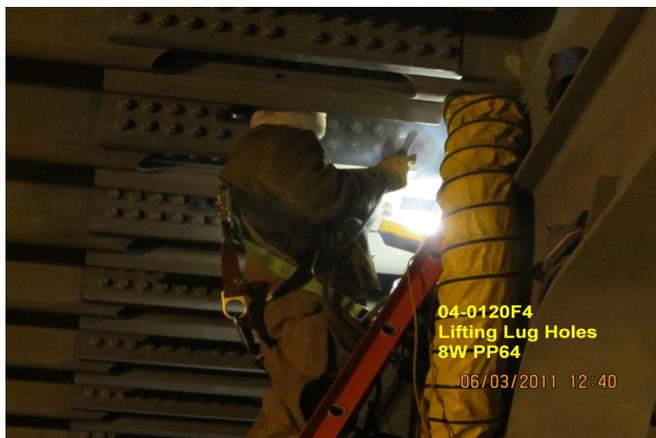
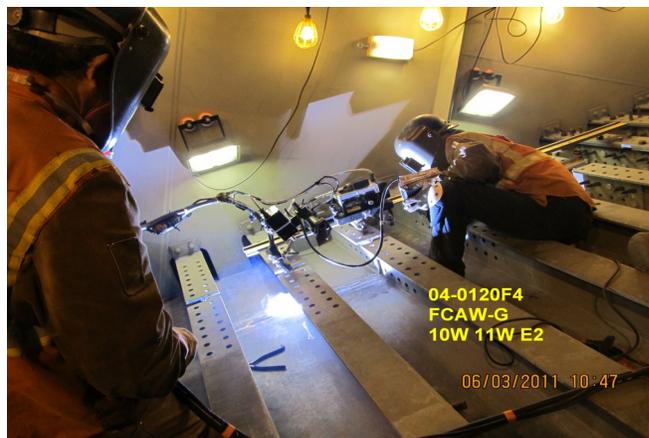
The QA Inspector made periodic observations of ABF welder Jason Collins performing Shielded Metal Arc Welding (SMAW) in the 4G overhead position on the Lifting Lug Holes (LLH) #1 and 3 located at 8E PP64 E4. The QA Inspector observed the QC Inspector Fred Von Hoff as being present in order to monitor the progress and ensure the welding parameters were in compliance pertaining to ABF-WPS-D15-1110A-Rev. 1. The work progressed throughout the shift and the QA Inspector noted that the work appeared to be in general conformance with the contract documents.

The QA Inspector made periodic observations of ABF welder Fred Kaddu performing Shielded Metal Arc Welding (SMAW) in the 4G overhead position on the LLH's #2 and 4 located at 8W PP64. The QA Inspector observed the QC Inspector John Pagliero as being present in order to monitor the progress and ensure the welding parameters were in compliance pertaining to ABF-WPS-D15-1110A Rev. 1. The QA Inspector noted that the work is in progress and appeared to be in general conformance with the contract documents.
