**DEPARTMENT OF TRANSPORTATION**

Contract #: 04-0120F4Cty: SF/ALA Rte: 80 PM: 13.2/13.9File #: 1.28**WELDING INSPECTION REPORT****Resident Engineer:** Siegenthaler, Peter**Address:** 333 Burma Road**City:** Oakland, CA 94607**Report No:** WIR-024283**Date Inspected:** 06-Jun-2011**Project Name:** SAS Superstructure**OSM Arrival Time:** 700**Prime Contractor:** American Bridge/Fluor Enterprises, a JV**OSM Departure Time:** 1530**Contractor:** American Bridge/Fluor Enterprises, a JV**Location:** Job Site**CWI Name:** Steve Jensen**CWI Present:** Yes No**Inspected CWI report:** Yes No N/A**Rod Oven in Use:** Yes No N/A**Electrode to specification:** Yes No N/A**Weld Procedures Followed:** Yes No N/A**Qualified Welders:** Yes No N/A**Verified Joint Fit-up:** Yes No N/A**Approved Drawings:** Yes No N/A**Approved WPS:** Yes No N/A**Delayed / Cancelled:** Yes No N/A**Bridge No:** 34-0006**Component:** Tower**Summary of Items Observed:**

114 Meter elevation – South Tower – Splice Plates

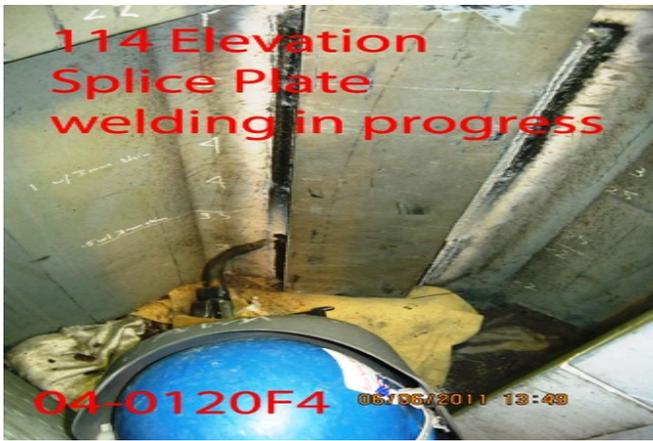
This QA Inspector observed ABF welding personnel Xiao Jian Wan (#9677) using the FCAW process at weld joint #166-South, the bottom half of the splice plate. This QA Inspector was present and randomly observed as QC Inspector Steve Jensen verified the following welding parameters; 259 amperes and 20.1 volts at a travel speed of 85 mm per minute to produce a heat input of 3.67 Kj per mm. The welding observed appeared to comply with

Welding Procedure Specification (WPS) ABF-WPS-D15-F2200-2. See photo below.

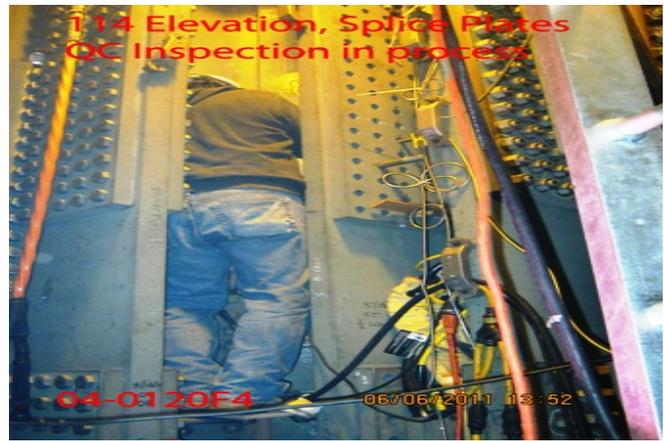
This QA Inspector made multiple trips to the location where welding was being performed above and observed QC Inspector Steve Jensen periodically monitoring the welding, see photo below. The work observed by this QA Inspector appeared to comply with the contract requirements.
