Contract #: 04-0120F4Cty: SF/ALA Rte: 80 PM: 13.2/13.9File #: 1.28**WELDING INSPECTION REPORT****Resident Engineer:** Siegenthaler, Peter**Address:** 333 Burma Road**City:** Oakland, CA 94607**Report No:** WIR-024323**Date Inspected:** 11-Jun-2011**Project Name:** SAS Superstructure**OSM Arrival Time:** 930**Prime Contractor:** American Bridge/Fluor Enterprises, a JV**OSM Departure Time:** 1800**Contractor:** American Bridge/Fluor Enterprises, a JV**Location:** Job Site

At Tower Base Elevation 13Meters Shear Plate Electro Slag Welding (ESW);

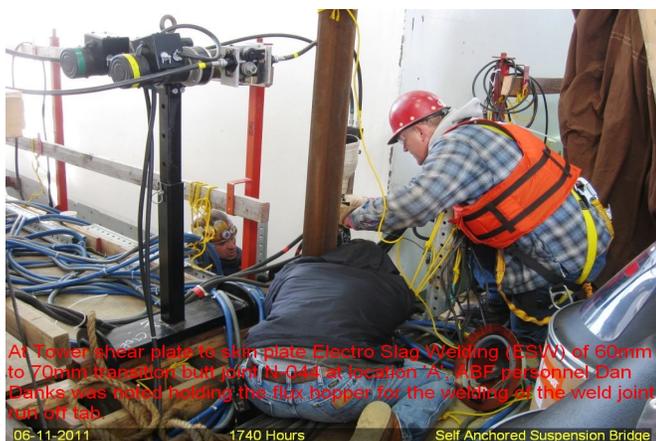
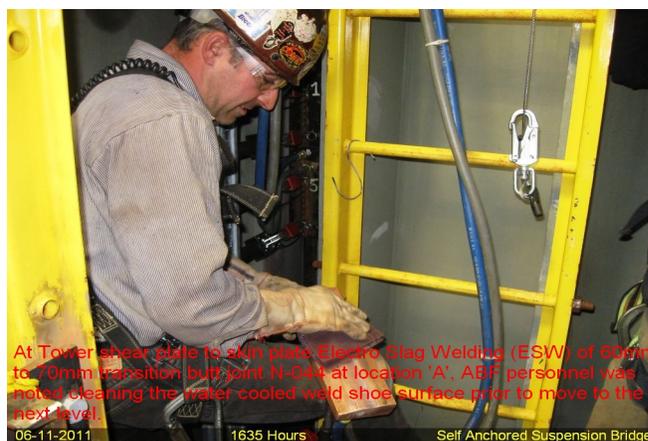
Initial firing of the ESW has started at 1322 hours and it was successful and that the welding parameters have stabilized and continued without a hitch until the completion of the joint at around 1738 hours.
