**DEPARTMENT OF TRANSPORTATION**

Quality Assurance and Source Inspection

Contract #: 04-0120F4Cty: SF/ALA Rte: 80 PM: 13.2/13.9File #: 1.28**WELDING INSPECTION REPORT****Resident Engineer:** Siegenthaler, Peter**Address:** 333 Burma Road**City:** Oakland, CA 94607**Report No:** WIR-024324**Date Inspected:** 11-Jun-2011**Project Name:** SAS Superstructure**OSM Arrival Time:** 700**Prime Contractor:** American Bridge/Fluor Enterprises, a JV**OSM Departure Time:** 1530**Contractor:** American Bridge/Fluor Enterprises, a JV**Location:** Job Site**CWI Name:** See Report Below**CWI Present:** Yes No**Inspected CWI report:** Yes No N/A**Rod Oven in Use:** Yes No N/A**Electrode to specification:** Yes No N/A**Weld Procedures Followed:** Yes No N/A**Qualified Welders:** Yes No N/A**Verified Joint Fit-up:** Yes No N/A**Approved Drawings:** Yes No N/A**Approved WPS:** Yes No N/A**Delayed / Cancelled:** Yes No N/A**Bridge No:** 34-0006**Component:** Orthotropic Box Girders & Tower**Summary of Items Observed:**

# WELDING INSPECTION REPORT

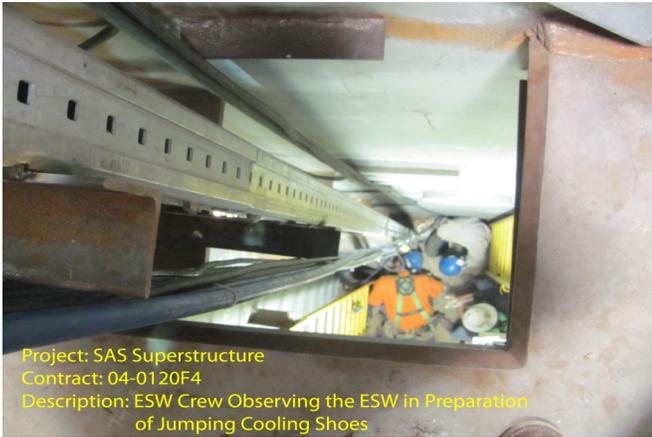
The QA observed the Electro Slag Welding (ESW) of the shear plate butt-joint identified as WN: N-044 as noted per the QC weld map. The butt-joint was located at the southwest corner of the north tower shaft starting at the tower base and extending to the 13 meter elevation and the shear plate components were identified as "a2" to the north shaft skin plate "A". The welding was performed by Dan Ieraci ID-3232 and Rory Hogan ID-3186 utilizing the WPS identified as ABF-WPS-ESW-60-70TR and the inspection was performed by QC personnel Mike Johnson and Steve McConnell. The welding commence at 1322 but was not completed during this QAI's scheduled shift. The ESW appeared to comply with the contract specifications.

The digital photograph below illustrate some of the work observed during this scheduled shift.
