**DEPARTMENT OF TRANSPORTATION**

Contract #: 04-0120F4Cty: SF/ALA Rte: 80 PM: 13.2/13.9File #: 1.28**WELDING INSPECTION REPORT****Resident Engineer:** Siegenthaler, Peter**Address:** 333 Burma Road**City:** Oakland, CA 94607**Report No:** WIR-024420**Date Inspected:** 14-Jun-2011**Project Name:** SAS Superstructure**OSM Arrival Time:** 700**Prime Contractor:** American Bridge/Fluor Enterprises, a JV**OSM Departure Time:** 1530**Contractor:** American Bridge/Fluor Enterprises, a JV**Location:** Job Site**CWI Name:** Steve Jensen**CWI Present:** Yes No**Inspected CWI report:** Yes No N/A**Rod Oven in Use:** Yes No N/A**Electrode to specification:** Yes No N/A**Weld Procedures Followed:** Yes No N/A**Qualified Welders:** Yes No N/A**Verified Joint Fit-up:** Yes No N/A**Approved Drawings:** Yes No N/A**Approved WPS:** Yes No N/A**Delayed / Cancelled:** Yes No N/A**Bridge No:** 34-0006**Component:** Tower**Summary of Items Observed:**

114 Meter elevation – West Tower – Splice Plates

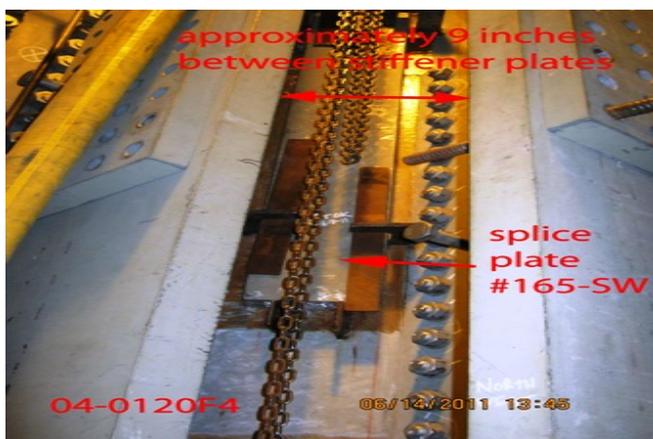
During this QA Inspectors' shift welding was periodically observed in both the West and South Towers this date. The progress of work appears to be slower due to the limited access for welding and grinding at all locations. See photo below of splice plate fit up, weld joint #165-Southwest, noting the limited access. This QA Inspector observed QC Inspector Steve Jensen at both locations to provide coverage monitoring the welding.
