DEPARTMENT OF TRANSPORTATION

Quality Assurance and Source Inspection

Contract #: 04-0120F4Cty: SF/ALA Rte: 80 PM: 13.2/13.9File #: 69.28**WELDING INSPECTION REPORT****Resident Engineer:** Siegenthaler, Peter**Address:** 333 Burma Road**City:** Oakland, CA 94607**Report No:** WIR-024475**Date Inspected:** 09-Jun-2011**Project Name:** SAS Superstructure**OSM Arrival Time:** 700**Prime Contractor:** American Bridge/Fluor Enterprises, a JV**OSM Departure Time:** 1900**Contractor:** Zhenhua Port Machinery Company, Ltd (ZPMC), Changxing Island **Location:** Shanghai, China**CWI Name:** Mr. Lu Hua Jie**CWI Present:** Yes No**Inspected CWI report:** Yes No N/A**Rod Oven in Use:** Yes No N/A**Electrode to specification:** Yes No N/A**Weld Procedures Followed:** Yes No N/A**Qualified Welders:** Yes No N/A**Verified Joint Fit-up:** Yes No N/A**Approved Drawings:** Yes No N/A**Approved WPS:** Yes No N/A**Delayed / Cancelled:** Yes No N/A**Bridge No:** 34-0006**Component:** Orthotropic Box Girder (OBG)**Summary of Items Observed:**

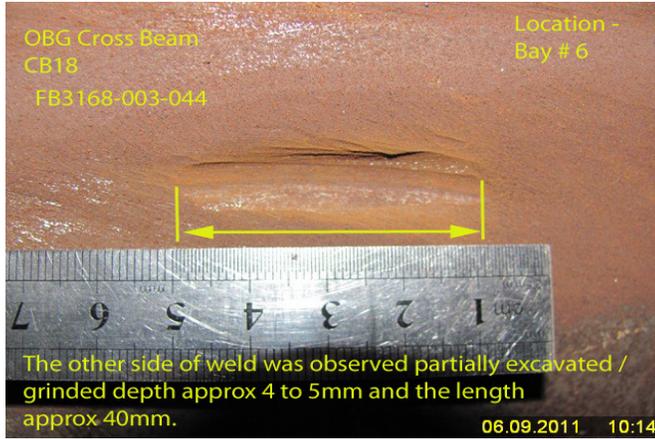
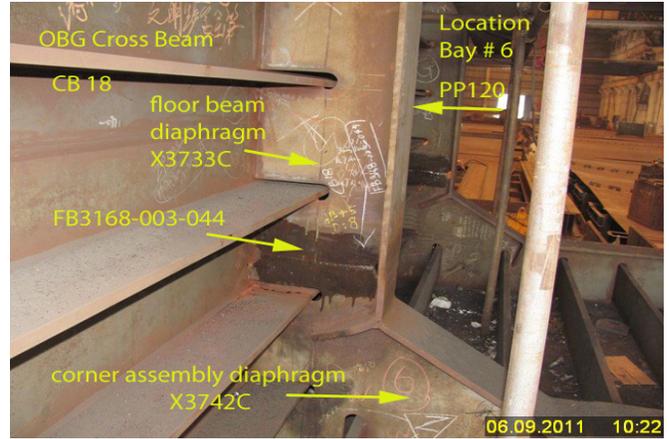
During the Quality Assurance Visual Inspection and Ultrasonic Testing (UT) review of welds located on OBG Cross Beam 18, this QA Inspector discovered the following issues: ZPMC Ultrasonic Testing (UT) technicians have tested and accepted a weld that did not meet the Visual Testing (VT) requirements of the contract documents. The weld is a Complete Joint Penetration (CJP) Butt-joint (joining the corner assembly diaphragm X3742C to floor beam diaphragm X3733C-Plate. The other side of weld was observed partially excavated/ground depth approx 4 to 5mm and the length approx 40mm. [at approx 150mm from side plate (SP) and no additional weld metal has been deposited. The weld is identified as FB3168-003-044 and is been accepted by ZPMC / ABF UT personnel. The weld is located at PP120. Material thickness is 12mm. The weld is designated as a Non Seismic Performance Critical Material (NON SPCM). The Notice of Witness Inspection Number (NWIT) is 09406. The indication is located within an area previously tested and accepted by ZPMC Quality control personal (See QC UT accepted chalk mark). For more information see below attached pictures and this QA inspector generated Incident report on this date.
