Contract #: 04-0120F4Cty: SF/ALA Rte: 80 PM: 13.2/13.9File #: 69.28**WELDING INSPECTION REPORT****Resident Engineer:** Siegenthaler, Peter**Address:** 333 Burma Road**City:** Oakland, CA 94607**Report No:** WIR-024478**Date Inspected:** 28-Dec-2010**Project Name:** SAS Superstructure**OSM Arrival Time:** 700**Prime Contractor:** American Bridge/Fluor Enterprises, a JV**OSM Departure Time:** 1900**Contractor:** Zhenhua Port Machinery Company, Ltd (ZPMC), Changxing Island **Location:** Shanghai, China**CWI Name:** Qiu Wen**CWI Present:** Yes No**Inspected CWI report:** Yes No N/A**Rod Oven in Use:** Yes No N/A**Electrode to specification:** Yes No N/A**Weld Procedures Followed:** Yes No N/A**Qualified Welders:** Yes No N/A**Verified Joint Fit-up:** Yes No N/A**Approved Drawings:** Yes No N/A**Approved WPS:** Yes No N/A**Delayed / Cancelled:** Yes No N/A**Bridge No:** 34-0006**Component:** OBG**Summary of Items Observed:**

BAY 14, OBG FLOOR BEAM HINGE PLATE (NWIT # 7964)

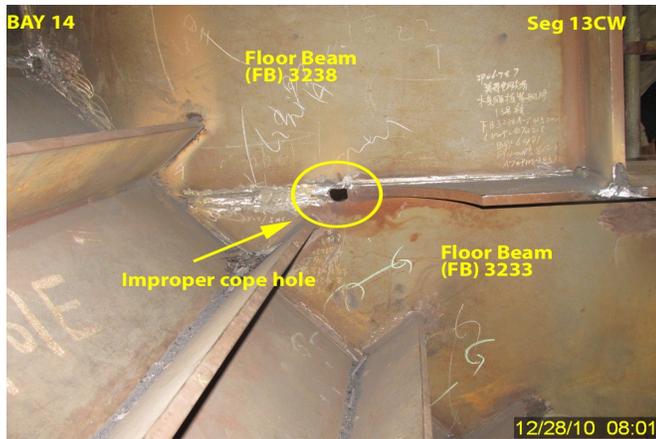
During random in process inspection this QA inspector observed that there was no cope hole/ rat hole at the intersection of Floor Beam (FB) 3238 to Floor Beam (FB) 3233 at Panel Point (PP) 124.5 of segment 13CW.

Adjacent weld numbers were identified as SEG3015B-106, 107 & 108. This issue has been discussed with ZPMC CWI Mr. Qiu Wen and CT lead QA. Mr. Qiu Wen informed this QA that the cope hole would be corrected in a manner compliant with the contract documents. Attached photograph provide additional details.

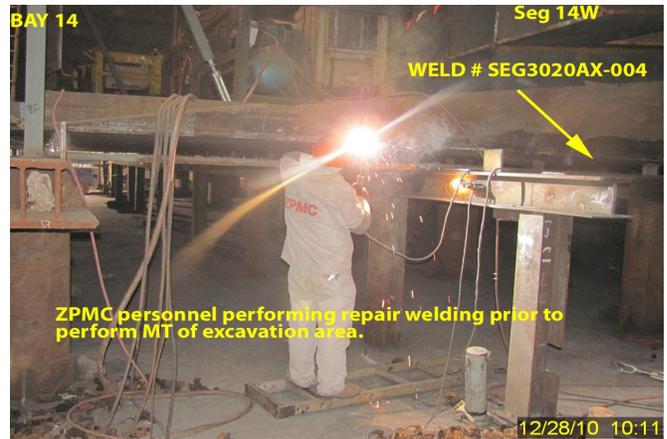
During random in process inspection this QA inspector observed that ZPMC personnel was performing repair welding of weld joint no: SEG3020AX-004 [Side Plate (SP) 3131A to Bottom Plate (BP) 3087A, complete joint penetration (CJP) weld at panel point (PP) 125.5]. The welder is identified as 045246 and was observed welding in the 4G position. Welding process was identified as Shielded Metal Arc Welding (SMAW). ZPMC QC was identified as Mr. Wang xiang Pin. This weld has been rejected two times by ZPMC NDT personnel previously. The primary requirement recorded by this QC prior to start repair welding does not appeared to comply with Critical Welding Repair (CWR) report B-CWR 2513, Rev. 0. ZPMC personnel started repair welding before performing MT of the excavation area. This issue has been discussed with ZPMC CWI Mr. Qiu Wen. ZPMC personnel ground out the welded portion and perform MT of the excavated area later on. Attached photograph provide additional detail.
