DEPARTMENT OF TRANSPORTATION

Quality Assurance and Source Inspection

Contract #: 04-0120F4Cty: SF/ALA Rte: 80 PM: 13.2/13.9File #: 69.28**WELDING INSPECTION REPORT****Resident Engineer:** Siegenthaler, Peter**Address:** 333 Burma Road**City:** Oakland, CA 94607**Report No:** WIR-024515**Date Inspected:** 28-May-2011**Project Name:** SAS Superstructure**OSM Arrival Time:** 700**Prime Contractor:** American Bridge/Fluor Enterprises, a JV**OSM Departure Time:** 1900**Contractor:** Zhenhua Port Machinery Company, Ltd (ZPMC), Changxing Island **Location:** Shanghai, China**CWI Name:** Liu Hua Jie**CWI Present:** Yes No**Inspected CWI report:** Yes No N/A**Rod Oven in Use:** Yes No N/A**Electrode to specification:** Yes No N/A**Weld Procedures Followed:** Yes No N/A**Qualified Welders:** Yes No N/A**Verified Joint Fit-up:** Yes No N/A**Approved Drawings:** Yes No N/A**Approved WPS:** Yes No N/A**Delayed / Cancelled:** Yes No N/A**Bridge No:** 34-0006**Component:** OBG COMPONENT**Summary of Items Observed:**

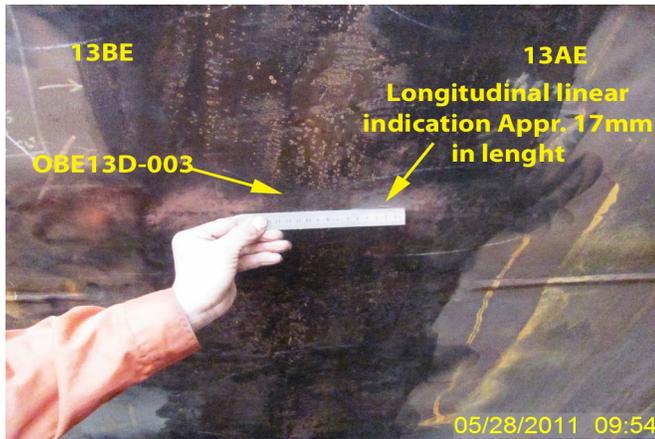
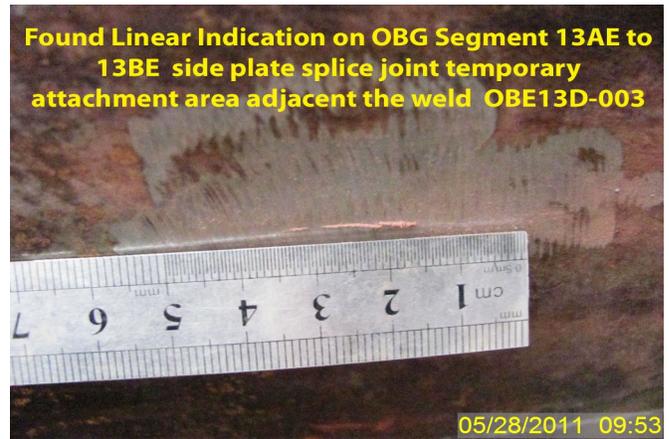
During the Quality Assurance Magnetic particle Testing (MT) review of welds located on Orthotropic Box Girder (OBG) Segment 13AE to 13BE side plate splice joint temporary attachment area adjacent the weld OBE13D-003 , this Quality Assurance Inspector (QA) discovered one (1) Longitudinal linear indication measuring approximately 18mm in length. After that the notification was canceled by ABF inspector Kevin Chen. This QA inspector did not generate an incident report on this date.
