DEPARTMENT OF TRANSPORTATION

Contract #: 04-0120F4Cty: SF/ALA Rte: 80 PM: 13.2/13.9File #: 1.28**WELDING INSPECTION REPORT****Resident Engineer:** Siegenthaler, Peter**Address:** 333 Burma Road**City:** Oakland, CA 94607**Report No:** WIR-024521**Date Inspected:** 20-Jun-2011**Project Name:** SAS Superstructure**OSM Arrival Time:** 700**Prime Contractor:** American Bridge/Fluor Enterprises, a JV**OSM Departure Time:** 1730**Contractor:** American Bridge/Fluor Enterprises, a JV**Location:** Job Site**CWI Name:** Steve Jensen**CWI Present:** Yes No**Inspected CWI report:** Yes No N/A**Rod Oven in Use:** Yes No N/A**Electrode to specification:** Yes No N/A**Weld Procedures Followed:** Yes No N/A**Qualified Welders:** Yes No N/A**Verified Joint Fit-up:** Yes No N/A**Approved Drawings:** Yes No N/A**Approved WPS:** Yes No N/A**Delayed / Cancelled:** Yes No N/A**Bridge No:** 34-0006**Component:** S.A.S. components**Summary of Items Observed:**

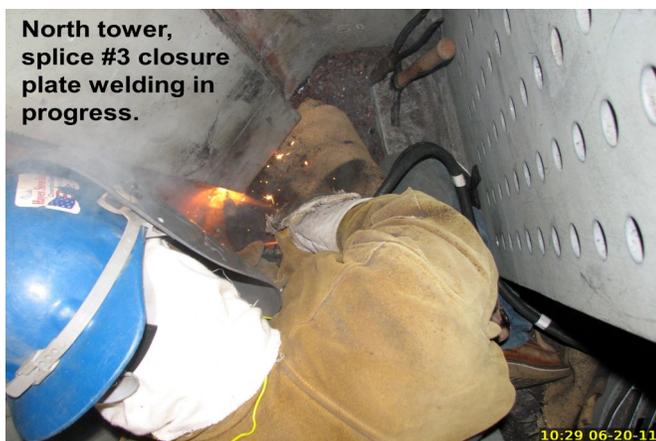
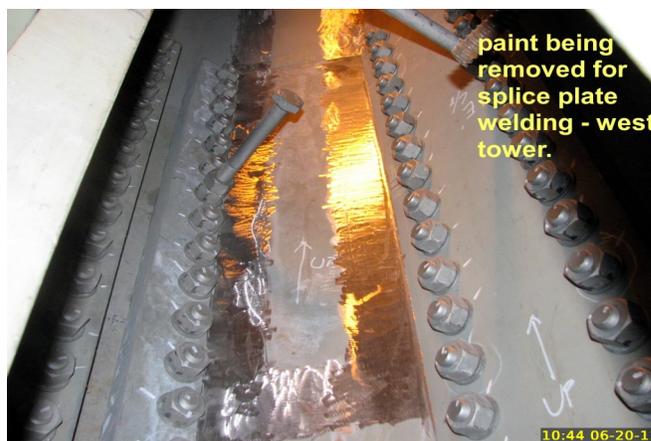
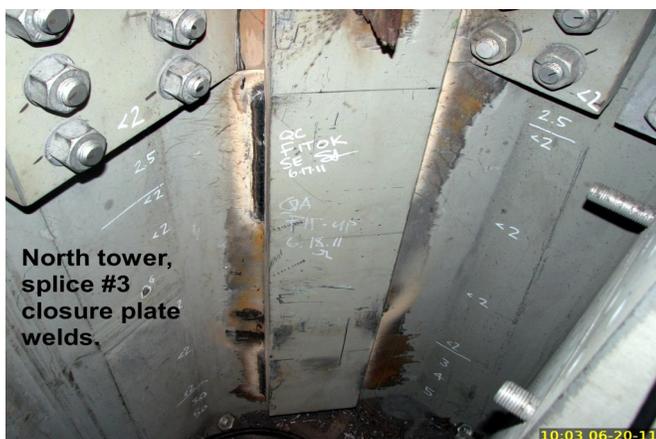
1) The QAI observed ABF personnel welding field splice closure plates inside the North tower shaft at field splice #3. The QAI observed Xiao Jian Wan, ID 9677, at the North lower plate (weld N166) and Salvador Sandoval, ID 2202, at the North-East lower plate (weld NE166). The QAI noted that both welders are making vertical fillet welds (3F) using self shielded flux cored arc welding (FCAW-S) with 1.8mm diameter E71T-8-H16 electrode (NR-232). The QAI observed that Quality Control Inspector (QCI) Steve Jensen is monitoring this welding. The QAI was informed that welding procedure specification ABF-WPS-D15-F2200-3 is being used for this welding. The QAI randomly measured the preheat, interpass temperature and welding parameters, with the exception of travel speed, and noted that they appeared to be conforming to the WPS requirements. As the welding progressed, the QAI observed that at weld N166, the welder appeared to be incorporating broken fit-up welds into the final fillet weld. The QAI asked the QCI why this was being done. The QCI verified the QAI's observation and remarked that the fit-up welds should have been removed. The QAI was informed that the welder has been instructed to grind the fit-up welds off including what has been incorporated into the fillet welds. The QAI estimated that approximately 5mm of weld has been incorporated on each side of the closure plate. The QAI was informed that this work will begin at the next shift and there was no more welding at this location during this shift.
