DEPARTMENT OF TRANSPORTATION

Quality Assurance and Source Inspection

Contract #: 04-0120F4Cty: SF/ALA Rte: 80 PM: 13.2/13.9File #: 1.28**WELDING INSPECTION REPORT****Resident Engineer:** Siegenthaler, Peter**Address:** 333 Burma Road**City:** Oakland, CA 94607**Report No:** WIR-024528**Date Inspected:** 22-Jun-2011**Project Name:** SAS Superstructure**OSM Arrival Time:** 700**Prime Contractor:** American Bridge/Fluor Enterprises, a JV**OSM Departure Time:** 1730**Contractor:** American Bridge/Fluor Enterprises, a JV**Location:** Job Site**CWI Name:** See Below**CWI Present:** Yes No**Inspected CWI report:** Yes No N/A**Rod Oven in Use:** Yes No N/A**Electrode to specification:** Yes No N/A**Weld Procedures Followed:** Yes No N/A**Qualified Welders:** Yes No N/A**Verified Joint Fit-up:** Yes No N/A**Approved Drawings:** Yes No N/A**Approved WPS:** Yes No N/A**Delayed / Cancelled:** Yes No N/A**Bridge No:** 34-0006**Component:** Orthotropic Box Girder & Tower**Summary of Items Observed:**

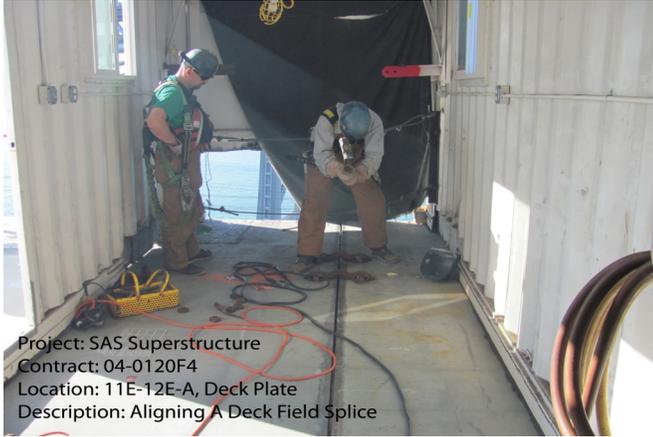
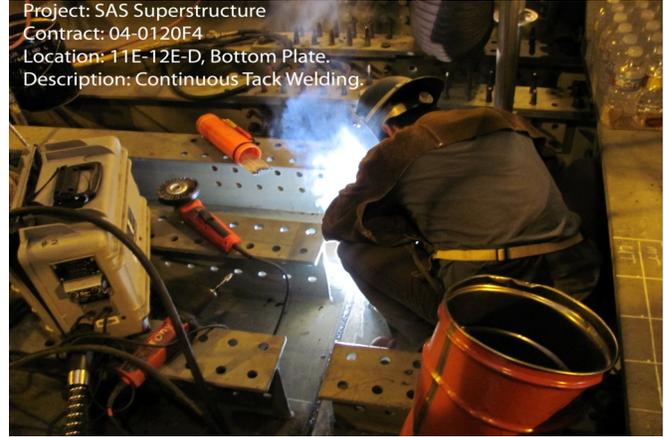
The digital photographs on page 3 of this report illustrate some of the work observed during this scheduled shift.
