DEPARTMENT OF TRANSPORTATION

Contract #: 04-0120F4Cty: SF/ALA Rte: 80 PM: 13.2/13.9File #: 69.28**WELDING INSPECTION REPORT****Resident Engineer:** Siegenthaler, Peter**Address:** 333 Burma Road**City:** Oakland, CA 94607**Report No:** WIR-024661**Date Inspected:** 11-Jun-2011**Project Name:** SAS Superstructure**OSM Arrival Time:** 700**Prime Contractor:** American Bridge/Fluor Enterprises, a JV**OSM Departure Time:** 1900**Contractor:** Zhenhua Port Machinery Company, Ltd (ZPMC), Changxing Island **Location:** Shanghai, China**CWI Name:** Mr. An Qing Xiang**CWI Present:** Yes No**Inspected CWI report:** Yes No N/A**Rod Oven in Use:** Yes No N/A**Electrode to specification:** Yes No N/A**Weld Procedures Followed:** Yes No N/A**Qualified Welders:** Yes No N/A**Verified Joint Fit-up:** Yes No N/A**Approved Drawings:** Yes No N/A**Approved WPS:** Yes No N/A**Delayed / Cancelled:** Yes No N/A**Bridge No:** 34-0006**Component:** Orthotropic Box Girder (OBG)**Summary of Items Observed:**

Segment: 13CW

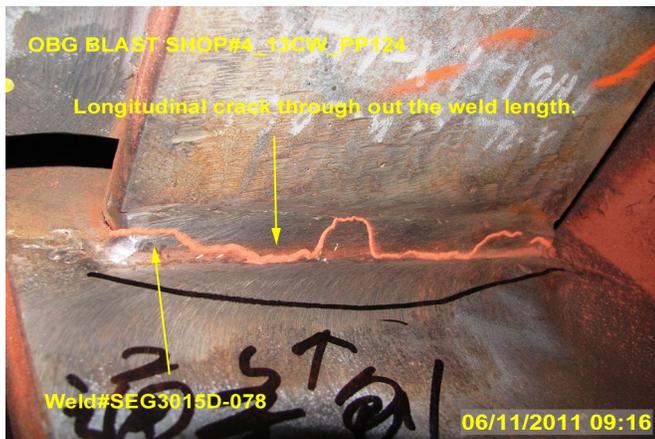
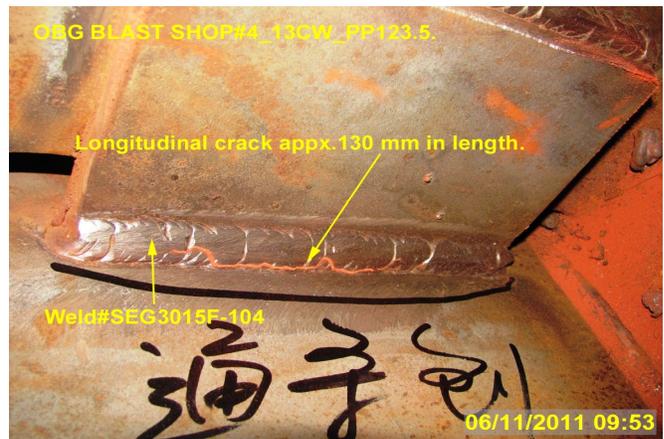
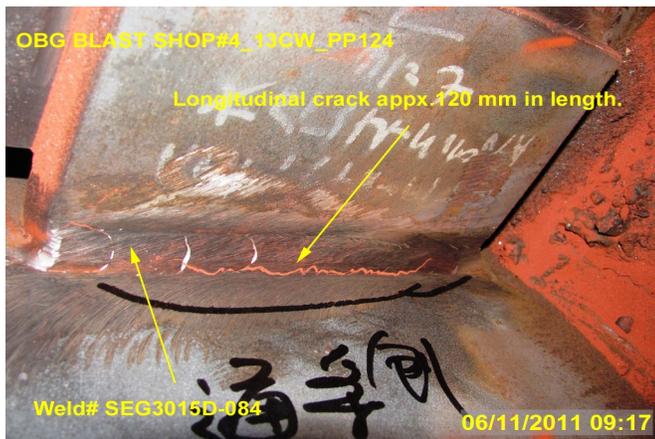
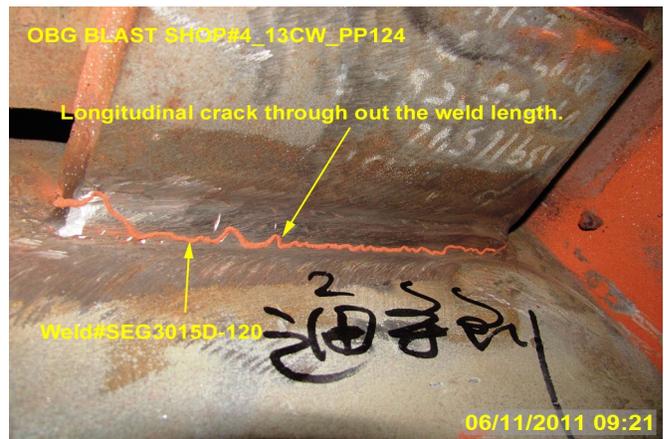
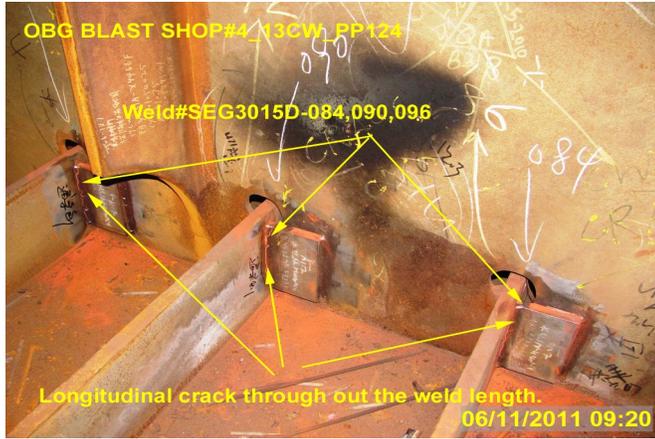
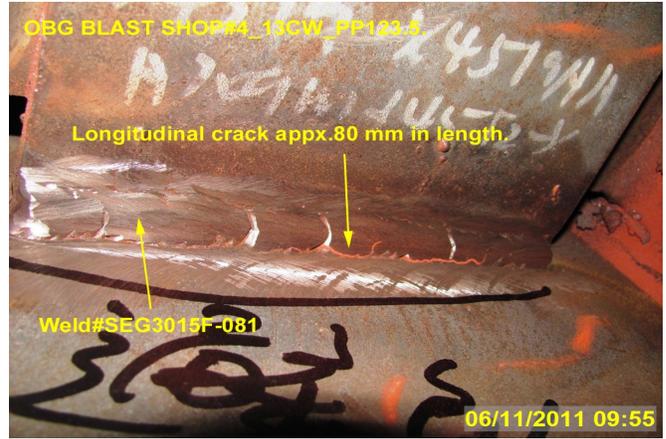
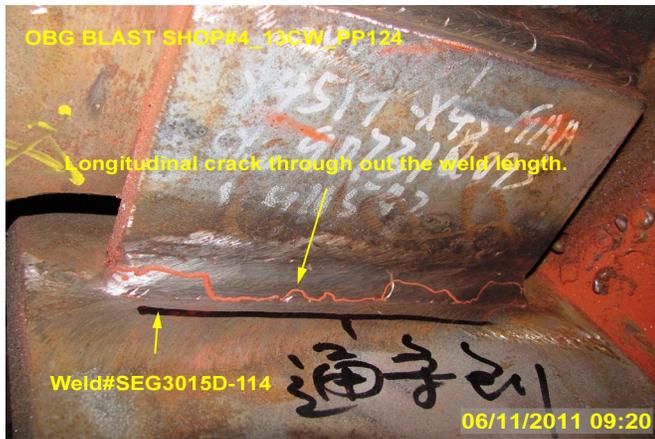
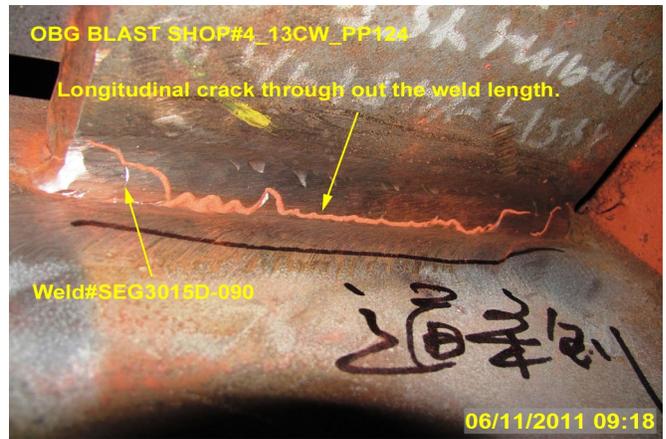
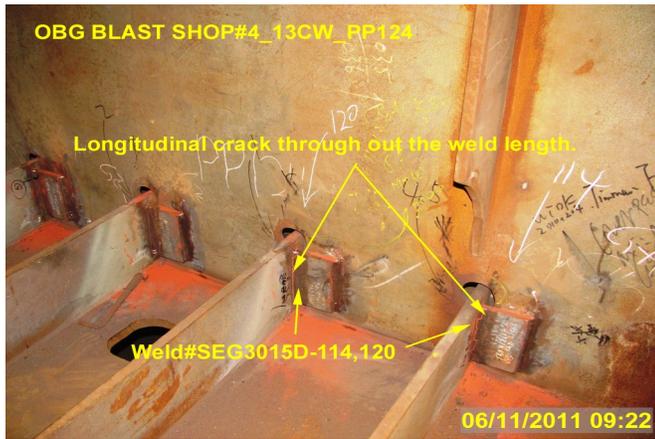
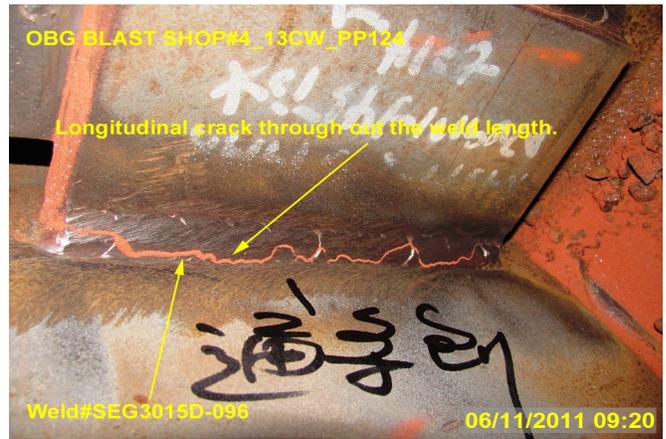
During random witness of weld joints is identified as SEG3015D-120,114,096,090,084,078 and SEG3015F-104, 081, this QA observed linear cracks on the welds. This QA along with ZPMC QC MT Technicians marked the affected areas and informed ZPMC Quality Control (QC) CWI indentified as Mr. An Qing Xiang of this issue. Mr. An Qing Xiang informed this QA that the cracks would be corrected in a manner compliant with the contract documents. This QA Inspector also informed to Lead QA Inspector of the issue. See attached photos for further details.
