Contract #: 04-0120F4Cty: SF/ALA Rte: 80 PM: 13.2/13.9File #: 69.28**WELDING INSPECTION REPORT****Resident Engineer:** Siegenthaler, Peter**Address:** 333 Burma Road**City:** Oakland, CA 94607**Report No:** WIR-024662**Date Inspected:** 09-Jun-2011**Project Name:** SAS Superstructure**OSM Arrival Time:** 700**Prime Contractor:** American Bridge/Fluor Enterprises, a JV**OSM Departure Time:** 1900**Contractor:** Zhenhua Port Machinery Company, Ltd (ZPMC), Changxing Island **Location:** Shanghai, China**CWI Name:** Mr. An Qing Xiang**CWI Present:** Yes No**Inspected CWI report:** Yes No N/A**Rod Oven in Use:** Yes No N/A**Electrode to specification:** Yes No N/A**Weld Procedures Followed:** Yes No N/A**Qualified Welders:** Yes No N/A**Verified Joint Fit-up:** Yes No N/A**Approved Drawings:** Yes No N/A**Approved WPS:** Yes No N/A**Delayed / Cancelled:** Yes No N/A**Bridge No:** 34-0006**Component:** Orthotropic Box Girder (OBG)**Summary of Items Observed:**

WELDING INSPECTION REPORT

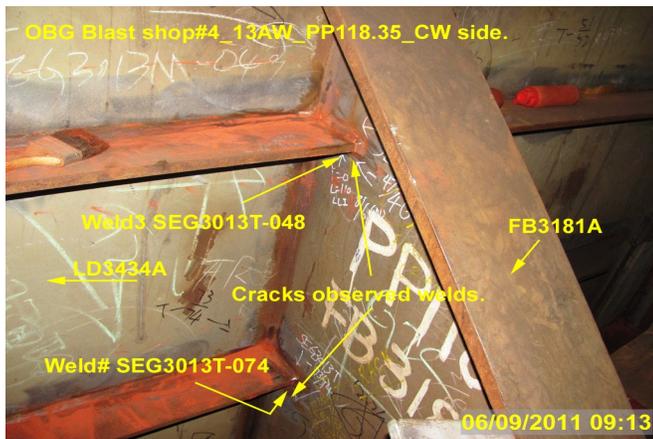
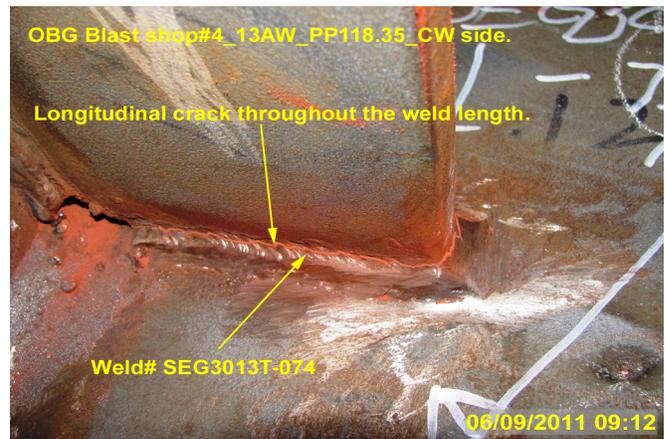
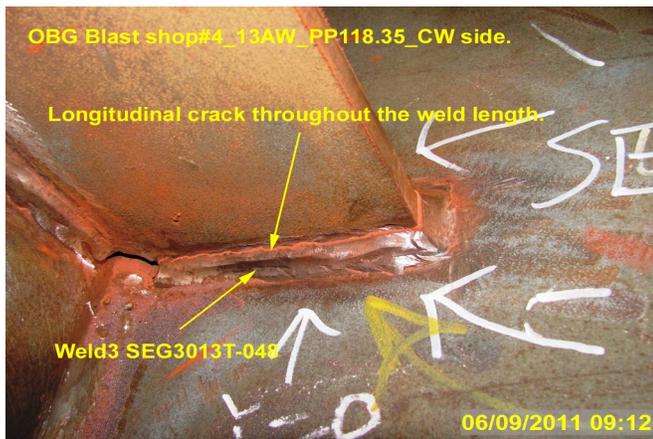
During random VT of OBG member identified as LD3434A and FB3181A, this QA observed 2 longitudinal linear cracks throughout the weld lengths. The weld joints are identified as SEG3013T-048 and 074. These cracks are confirmed by MT by this QA and marked the affected areas and informed ZPMC Quality Control (QC) CWI identified as Mr. An Qing Xiang of this issue. Mr. An Qing Xiang informed this QA that the cracks would be corrected in a manner compliant with the contract documents. This QA Inspector also informed to Lead QA Inspector of the issue. See attached photos for further details.
