DEPARTMENT OF TRANSPORTATION

Contract #: 04-0120F4Cty: SF/ALA Rte: 80 PM: 13.2/13.9File #: 69.28**WELDING INSPECTION REPORT****Resident Engineer:** Siegenthaler, Peter**Address:** 333 Burma Road**City:** Oakland, CA 94607**Report No:** WIR-024716**Date Inspected:** 17-Jun-2011**Project Name:** SAS Superstructure**OSM Arrival Time:** 700**Prime Contractor:** American Bridge/Fluor Enterprises, a JV**OSM Departure Time:** 1900**Contractor:** Zhenhua Port Machinery Company, Ltd (ZPMC), Changxing Island **Location:** Shanghai, China

Orthotropic Box Girder (OBG) at Trial Assembly Areas

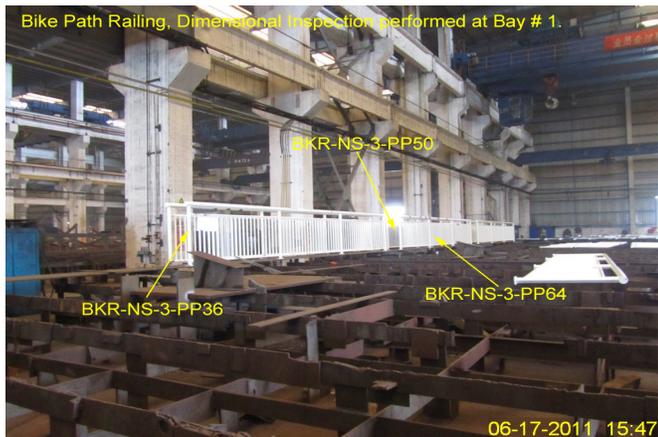
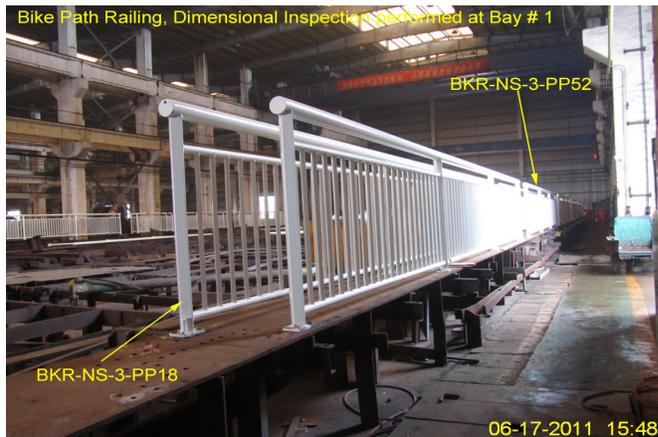
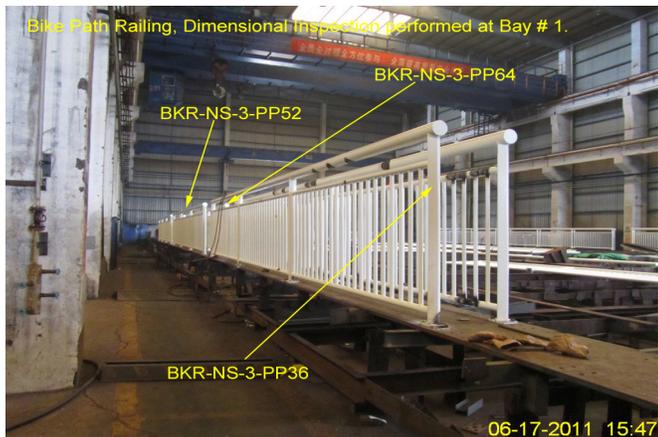
Note: 1. Bike Path Bottom Plate dimension inspection performed observed several locations dimension out of

tolerance, observed ZPMC performing Heat Straightening for BK-024A.

2. Bike Path Bottom Plate dimension inspection performed observed several locations dimension out of tolerance, observed ZPMC performing Heat Straightening for BK-025A.
