DEPARTMENT OF TRANSPORTATION

Contract #: 04-0120F4Cty: SF/ALA Rte: 80 PM: 13.2/13.9File #: 69.28**WELDING INSPECTION REPORT****Resident Engineer:** Siegenthaler, Peter**Address:** 333 Burma Road**City:** Oakland, CA 94607**Report No:** WIR-024744**Date Inspected:** 11-Jun-2011**Project Name:** SAS Superstructure**OSM Arrival Time:** 1900**Prime Contractor:** American Bridge/Fluor Enterprises, a JV**OSM Departure Time:** 700**Contractor:** Zhenhua Port Machinery Company, Ltd (ZPMC), Changxing Island **Location:** Shanghai, China

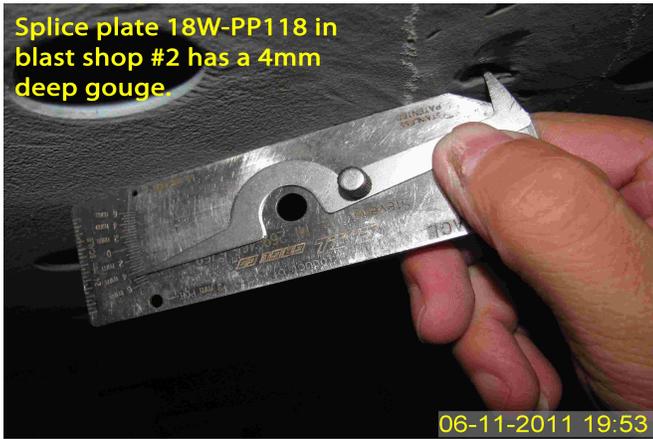
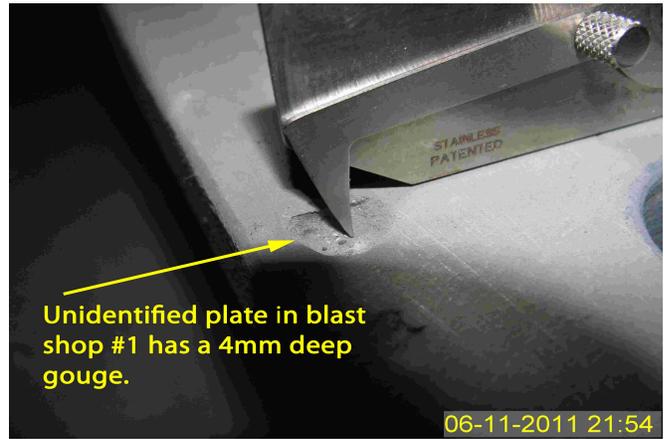
Caltrans Coating Inspector Mr. Kenneth Cason identified two splice plates that have gouges in the plates. One of these plates, identification number not available, is located in blast shop #1 and the second plate identified as #18W-PP118 is in blast shop #2. The gouges in each of the two plates have a maximum depth of approximately 4 millimeters. This QA Inspector took digital photographs of these gouges and forwarded the photographs and other information to dayshift personnel for resolution of these problems. See the photographs below for additional information.
