DEPARTMENT OF TRANSPORTATION

Contract #: 04-0120F4Cty: SF/ALA Rte: 80 PM: 13.2/13.9File #: 1.28**WELDING INSPECTION REPORT****Resident Engineer:** Siegenthaler, Peter**Address:** 333 Burma Road**City:** Oakland, CA 94607**Report No:** WIR-024757**Date Inspected:** 28-Jun-2011**Project Name:** SAS Superstructure**OSM Arrival Time:** 700**Prime Contractor:** American Bridge/Fluor Enterprises, a JV**OSM Departure Time:** 1530**Contractor:** American Bridge/Fluor Enterprises, a JV**Location:** Job Site

Bridge No: 34-0006**Component:** SAS Tower**Summary of Items Observed:**

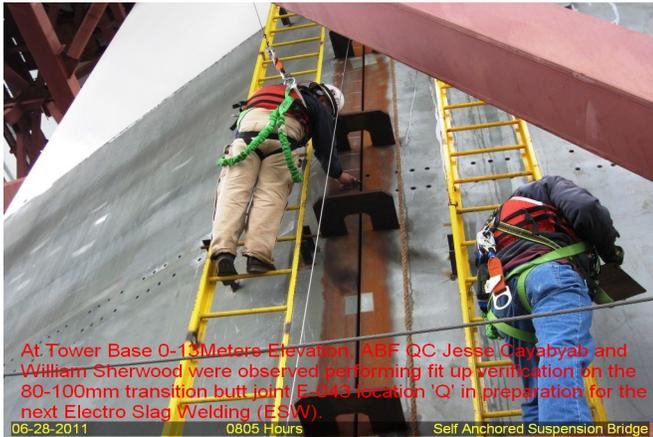
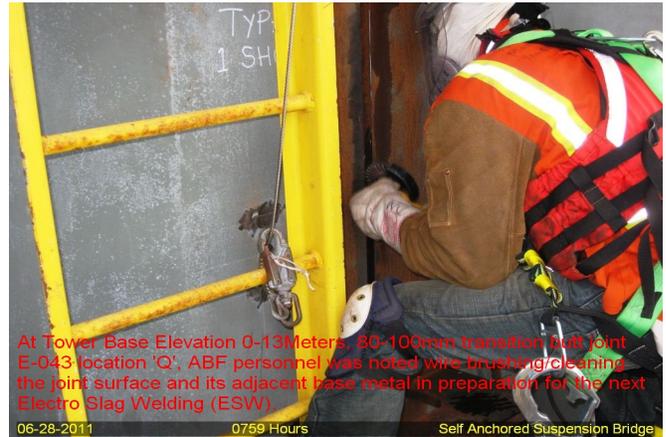
This QA together with ABF QC Jesse Cayabyab performed a joint fit up inspection/verification on the alignment of the 80-100mm transition butt joint E-043 at location 'Q' in preparation for the next ESW that is scheduled tomorrow. The root gap and offset were measured from bottom to top. The result noted on the offset verification was less than 3.0mm on most of the part except on the following which has exceeded the maximum allowed;

Y-location Offset/Misalignment Length
5100mm to 9780mm 6mm 4680mm
4640mm to 5100mm 4mm 460mm
2030mm to 4640mm 2mm 2610mm

The root gap measured was 16mm minimum and 25mm maximum which appears in compliance to the approved WPS.
