**DEPARTMENT OF TRANSPORTATION**

Contract #: 04-0120F4Cty: SF/Ala Rte: 80 PM: 13.2/13.9File #: 69.28**WELDING INSPECTION REPORT****Resident Engineer:** Siegenthaler, Peter**Address:** 333 Burma Road**City:** Oakland, CA 94607**Report No:** WIR-024779**Date Inspected:** 01-Jun-2011**Project Name:** SAS Superstructure**OSM Arrival Time:** 1900**Prime Contractor:** American Bridge/Fluor Enterprises, a JV**OSM Departure Time:** 700**Contractor:** Zhenhua Port Machinery Company, Ltd (ZPMC), Changxing Island **Location:** Shanghai, China**CWI Name:** See below**CWI Present:** Yes No**Inspected CWI report:** Yes No N/A**Rod Oven in Use:** Yes No N/A**Electrode to specification:** Yes No N/A**Weld Procedures Followed:** Yes No N/A**Qualified Welders:** Yes No N/A**Verified Joint Fit-up:** Yes No N/A**Approved Drawings:** Yes No N/A**Approved WPS:** Yes No N/A**Delayed / Cancelled:** Yes No N/A**Bridge No:** 34-0006**Component:** OBG Components**Summary of Items Observed:**

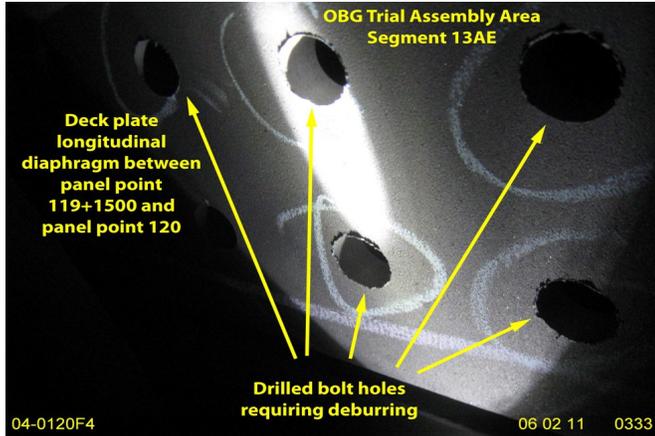
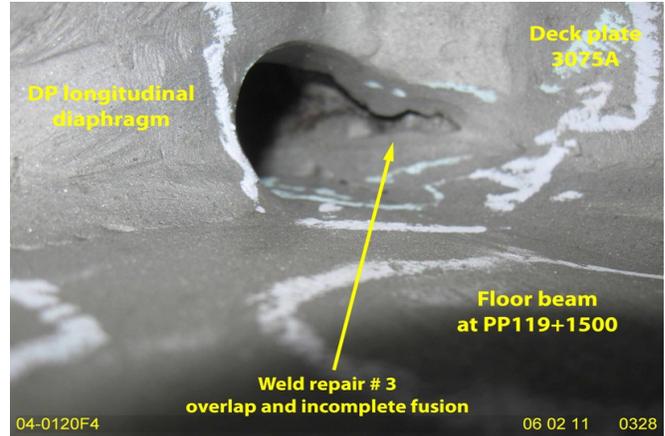
This QA Inspector, QA Inspector Kelly Leavitt (QA2), and QA Inspector Paul Dawson (QA3) responding to phone notification from ABF Inspectors performed a pre-final sandblast inspection inside Segment 13AE, , between panel points 119+1500 and 120, south (crossbeam) side, from deck plate down approximately 1 meter. This QA Inspector, QA2, and QA3 observed 3 indications appearing to require weld repair as well as surface irregularities requiring grinding, including approximately 30 drilled bolt holes which had not been deburred. These areas were marked and documented. See photo below of one of the 3 indications of a weld relief hole showing incomplete fusion and overlap of the weld at the junction of deck plate, floor beam at panel point 119+1500, and deck plate longitudinal diaphragm. See also photo below of 5 of the drilled bolt holes needing deburring.
