**DEPARTMENT OF TRANSPORTATION**

Contract #: 04-0120F4Cty: SF/ALA Rte: 80 PM: 13.2/13.9File #: 99.28**WELDING INSPECTION REPORT****Resident Engineer:** Siegenthaler, Peter**Address:** 333 Burma Road**City:** Oakland, CA 94607**Report No:** WIR-024793**Date Inspected:** 28-Jun-2011**Project Name:** SAS Superstructure**OSM Arrival Time:** 1500**Prime Contractor:** American Bridge/Fluor Enterprises, a JV**OSM Departure Time:** 300**Contractor:** Zhenhua Port Machinery Company, Ltd (ZPMC) Changxing Island **Location:** Shanghai, China

OBG Lift 14E

# WELDING INSPECTION REPORT

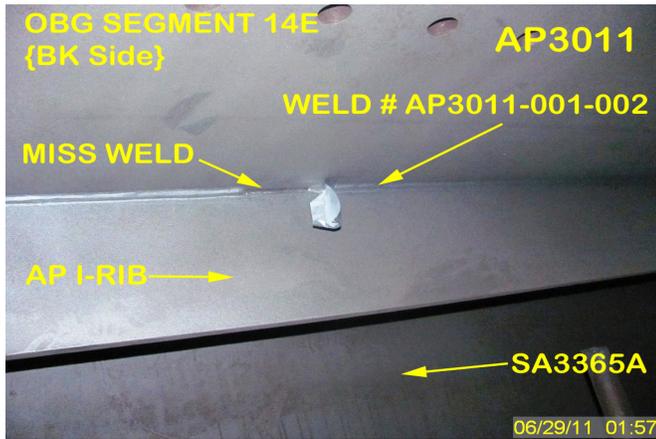
During the Quality Assurance Inspection of Visual testing (VT) of Post blast inspection of Anchor Plates internal surfaces in between PP125 to PP126 of the OBG 14E {BK Side}, this Quality Assurance Inspector (QA) discovered the Miss Weld on weld joints identified is AP3011-001-002 and 003. The location is marked up for weld repair and was recorded on a weld map for future repair. For further information, please see the attached pictures below:
