Contract #: 04-0120F4Cty: SF/ALA Rte: 80 PM: 13.2/13.9File #: 69.28**WELDING INSPECTION REPORT****Resident Engineer:** Siegenthaler, Peter**Address:** 333 Burma Road**City:** Oakland, CA 94607**Report No:** WIR-024802**Date Inspected:** 28-Jun-2011**Project Name:** SAS Superstructure**OSM Arrival Time:** 1500**Prime Contractor:** American Bridge/Fluor Enterprises, a JV**OSM Departure Time:** 300**Contractor:** Zhenhua Port Machinery Company, Ltd (ZPMC), Changxing Island **Location:** Shanghai, China**CWI Name:** Mr. Li Yang ZPMC**CWI Present:** Yes No**Inspected CWI report:** Yes No N/A**Rod Oven in Use:** Yes No N/A**Electrode to specification:** Yes No N/A**Weld Procedures Followed:** Yes No N/A**Qualified Welders:** Yes No N/A**Verified Joint Fit-up:** Yes No N/A**Approved Drawings:** Yes No N/A**Approved WPS:** Yes No N/A**Delayed / Cancelled:** Yes No N/A**Bridge No:** 34-0006**Component:** 13BW~13CW Blast Shop 4**Summary of Items Observed:**

OBG13BW~13CW

BLAST SHOP 4

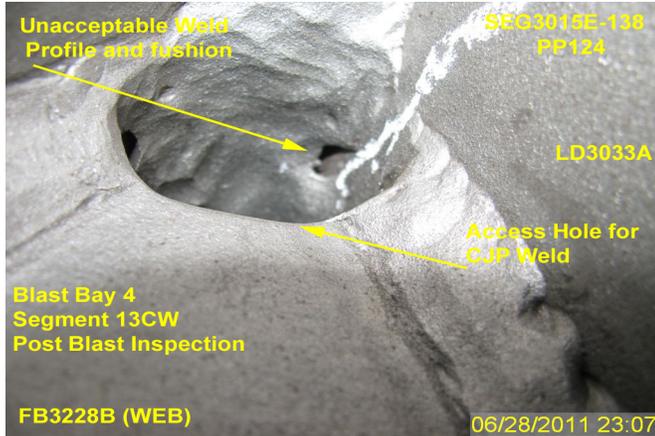
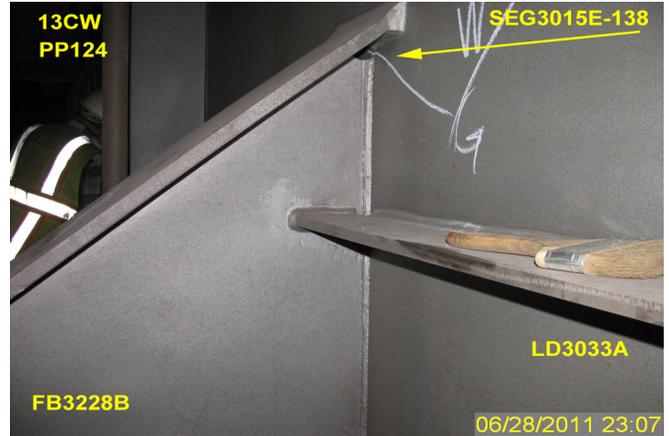
During the Quality Assurance Visual Testing (VT) of Post blast inspection; this QA inspector performed a visual inspection on internal box surfaces. The areas that were presented to this QA inspector was between PP 120.0 to PP125.0, between the Longitudinal Diaphragms, Floor Beams, Lifting Lugs, Longitudinal Diaphragm Stiffeners Bottom Plate and Rib Stiffeners. This QA inspector found multiple areas requiring additional grinding, and cleaning. The areas that only required grinding were marked for repair, and the ABF Quality Control / Quality Assurance was notified of the locations marked. The information was transferred to the appropriate weld maps and post blast inspection report and sent to the appropriate personnel for tracking and punch list.
