Contract #: 04-0120F4Cty: SF/ALA Rte: 80 PM: 13.2/13.9File #: 69.28**WELDING INSPECTION REPORT****Resident Engineer:** Siegenthaler, Peter**Address:** 333 Burma Road**City:** Oakland, CA 94607**Report No:** WIR-024805**Date Inspected:** 25-Jun-2011**Project Name:** SAS Superstructure**OSM Arrival Time:** 1500**Prime Contractor:** American Bridge/Fluor Enterprises, a JV**OSM Departure Time:** 300**Contractor:** Zhenhua Port Machinery Company, Ltd (ZPMC), Changxing Island **Location:** Shanghai, China**CWI Name:** Mr. Li Yang ZPMC**CWI Present:** Yes No**Inspected CWI report:** Yes No N/A**Rod Oven in Use:** Yes No N/A**Electrode to specification:** Yes No N/A**Weld Procedures Followed:** Yes No N/A**Qualified Welders:** Yes No N/A**Verified Joint Fit-up:** Yes No N/A**Approved Drawings:** Yes No N/A**Approved WPS:** Yes No N/A**Delayed / Cancelled:** Yes No N/A**Bridge No:** 34-0006**Component:** 13BE, CE and 13CW**Summary of Items Observed:**

# WELDING INSPECTION REPORT

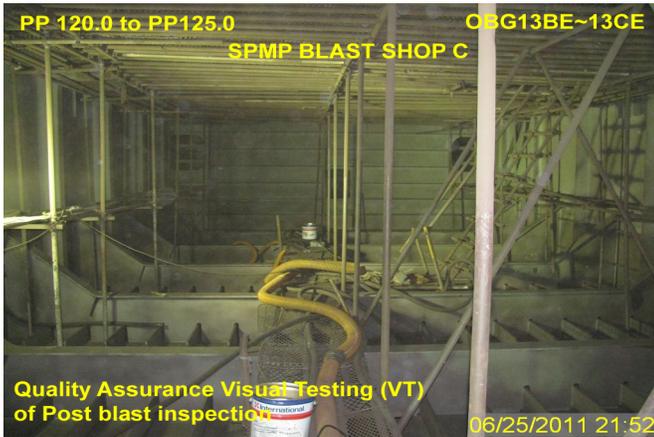
During the Quality Assurance Visual Testing (VT) of Post blast inspection; this QA inspector performed a visual inspection on internal box surfaces. The areas that were presented to this QA inspector was between PP 122 to PP 123, Side Plate, Rib Stiffeners, Floor Beam, and Edge Beam. This QA inspector found multiple areas requiring additional grinding, and cleaning. The areas that only required grinding were marked for repair, and the ABF

Quality Control / Quality Assurance was notified of the locations marked. The information was transferred to the appropriate weld maps and post blast inspection report and sent to the appropriate personnel for tracking and punch list.
