DEPARTMENT OF TRANSPORTATION

Contract #: 04-0120F4Cty: SF/ALA Rte: 80 PM: 13.2/13.9File #: 69.28**WELDING INSPECTION REPORT****Resident Engineer:** Siegenthaler, Peter**Address:** 333 Burma Road**City:** Oakland, CA 94607**Report No:** WIR-024814**Date Inspected:** 27-Jun-2011**Project Name:** SAS Superstructure**OSM Arrival Time:** 1500**Prime Contractor:** American Bridge/Fluor Enterprises, a JV**OSM Departure Time:** 300**Contractor:** Zhenhua Port Machinery Company, Ltd (ZPMC), Changxing Island **Location:** Shanghai, China**CWI Name:** See Below**CWI Present:** Yes No**Inspected CWI report:** Yes No N/A**Rod Oven in Use:** Yes No N/A**Electrode to specification:** Yes No N/A**Weld Procedures Followed:** Yes No N/A**Qualified Welders:** Yes No N/A**Verified Joint Fit-up:** Yes No N/A**Approved Drawings:** Yes No N/A**Approved WPS:** Yes No N/A**Delayed / Cancelled:** Yes No N/A**Bridge No:** 34-0006**Component:** OBG**Summary of Items Observed:**

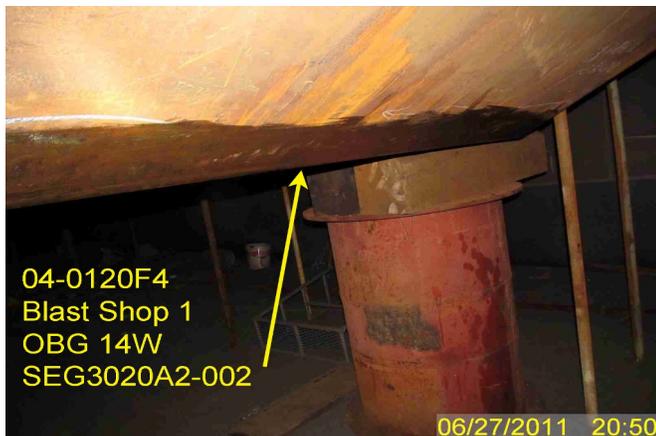
Bottom Plate to Side Plate (W4)
SEG3020A-002

At the time of the verification it was noted that the above component appeared to be within compliance of the contract documents. See Caltrans Ultrasonic Test Report (TL6027), dated 06-27-2011 for additional information. The following digital picture illustrates UT inspection of the weld.
