DEPARTMENT OF TRANSPORTATION

Contract #: 04-0120F4Cty: SF/ALA Rte: 80 PM: 13.2/13.9File #: 69.28**WELDING INSPECTION REPORT****Resident Engineer:** Siegenthaler, Peter**Address:** 333 Burma Road**City:** Oakland, CA 94607**Report No:** WIR-024823**Date Inspected:** 27-Jun-2011**Project Name:** SAS Superstructure**OSM Arrival Time:** 700**Prime Contractor:** American Bridge/Fluor Enterprises, a JV**OSM Departure Time:** 1900**Contractor:** Zhenhua Port Machinery Company, Ltd (ZPMC), Changxing Island **Location:** Shanghai, China**CWI Name:** Mr. Lu Hua Jie**CWI Present:** Yes No**Inspected CWI report:** Yes No N/A**Rod Oven in Use:** Yes No N/A**Electrode to specification:** Yes No N/A**Weld Procedures Followed:** Yes No N/A**Qualified Welders:** Yes No N/A**Verified Joint Fit-up:** Yes No N/A**Approved Drawings:** Yes No N/A**Approved WPS:** Yes No N/A**Delayed / Cancelled:** Yes No N/A**Bridge No:** 34-0006**Component:** Orthotropic Box Girder (OBG)**Summary of Items Observed:**

WELDING INSPECTION REPORT

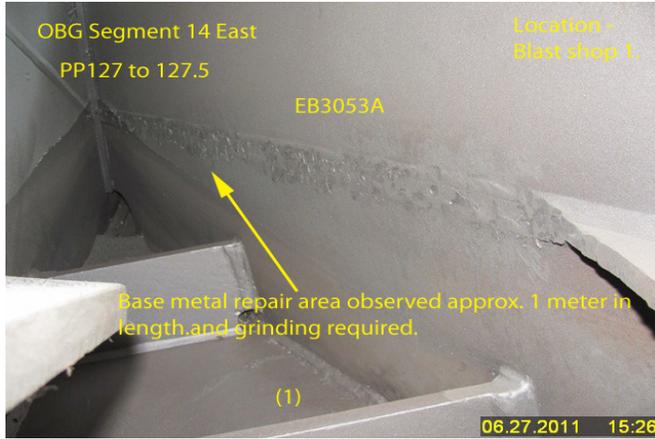
Visual Inspection after Blast at OBG Segment 14 East.

This Quality Assurance (QA) Inspector performed random visual inspection of OBG Segment 14 East Internal side, side panel and edge panel surfaces after grit blasting. Areas that marked for repair were recorded for future repair. Areas requiring additional grinding were marked by QA and repaired by ZPMC personnel. For more information see below attached picture number 1.
