Contract #: 04-0120F4Cty: SF/ALA Rte: 80 PM: 13.2/13.9File #: 99.28**WELDING INSPECTION REPORT****Resident Engineer:** Siegenthaler, Peter**Address:** 333 Burma Road**City:** Oakland, CA 94607**Report No:** WIR-024830**Date Inspected:** 30-Jun-2011**Project Name:** SAS Superstructure**OSM Arrival Time:** 700**Prime Contractor:** American Bridge/Fluor Enterprises, a JV**OSM Departure Time:** 1900**Contractor:** Zhenhua Port Machinery Company, Ltd (ZPMC) Chanxing Island**Location:** Shanghai, China**CWI Name:** Mr. Shi Lei**CWI Present:** Yes No**Inspected CWI report:** Yes No N/A**Rod Oven in Use:** Yes No N/A**Electrode to specification:** Yes No N/A**Weld Procedures Followed:** Yes No N/A**Qualified Welders:** Yes No N/A**Verified Joint Fit-up:** Yes No N/A**Approved Drawings:** Yes No N/A**Approved WPS:** Yes No N/A**Delayed / Cancelled:** Yes No N/A**Bridge No:** 34-0006**Component:** OBG Segment**Summary of Items Observed:**

OBG Segment 14W

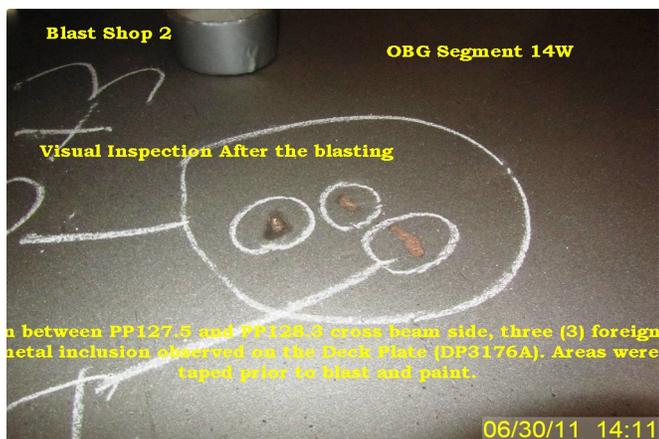
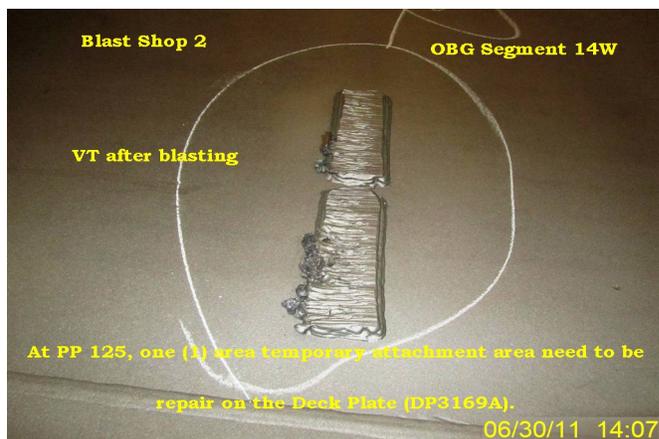
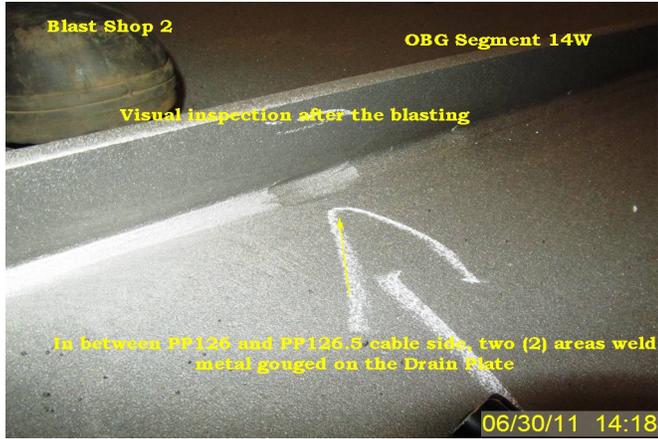
Visual inspection after the blasting: During random Quality Assurance Visual review of welds located on OBG Segment 14W, this Quality Assurance Inspector (QA) observed following details:

- At PP 128.3 cross beam side near SA3416C, base metal repair need to be done on Deck Panel Diaphragm.
- At PP128.3 cross beam side, two base metal gouge was visibly observed on the SA3416C.
- At PP128.7 middle, temporary attachment was not yet removed on SA3416A.
- In between PP125 and PP127 cross beam side, total four (4) areas temporary attachment area need to be repair on

- In between PP126.5 and PP127.5 cross beam side, one base metal gouge and one temporary attachment was not removed on the Deck Plate (DP3177A). Areas were taped prior to blast and paint.

- In between PP127.5 and PP128.3 cross beam side, three (3) foreign metal inclusion observed on the Deck Plate (DP3176A). Areas were taped prior to blast and paint.

- In between PP126 and PP126.5, one base metal gouge was visibly observed on the Deck Plate (DP3174A).
- In between PP125 and PP126, one (1) area temporary attachment area need to be repair on the Deck Plate (DP3173A).

- In between PP126 and PP126.5, one base metal gouge was visibly observed on the Deck Plate (DP3172A).
- In between PP125 and PP125.5 cross beam side, one (1) foreign metal inclusion observed on the Deck Plate (DP3171A) between W3 and W20 locations. Areas were taped prior to blast and paint.

- At PP 125, one base metal gouge was visibly observed on the Deck Plate (DP3170A).
- In between PP124.5 and PP126, two (2) base metal gouge was visibly observed on the Deck Plate (DP3169A).

- At PP 125, one (1) area temporary attachment area need to be repair on the Deck Plate ((DP3169A).
- In between PP126 and PP126.5 cable side, two (2) areas weld metal gouged on the Drain Plate.

- In between PP127 and PP128 cross beam side, four (4) areas temporary attachment area need to be repair on the side plate (SP3143A and SP3142E).
- In between PP127 and PP128 cross beam side, one base metal gouge was visibly observed on side plate (SP3142E).

- In between PP127 and PP128 cross beam side, scattered porosity observed on side plate (SP3143A). Areas were taped prior to blast and paint.
- At PP 127 cross beam side, scattered porosity observed on floor beam outside 2rd stiffener to floor beam (FL3). Areas were taped prior to blast and paint.

- In between PP127 and PP128 cable Side, four (4) areas temporary attachment area need to be repair on the side plate (SP3133A and SP3134A).
- At PP 128.7 middle, one base metal gouge was visibly observed on floor beam.

- At PP 128.7 cross beam side, one (1) area need to be welded on side plate to edge plate.
- For further information, please see the attached picture
