DEPARTMENT OF TRANSPORTATION

Contract #: 04-0120F4Cty: SF/ALA Rte: 80 PM: 13.2/13.9File #: 99.28**WELDING INSPECTION REPORT****Resident Engineer:** Siegenthaler, Peter**Address:** 333 Burma Road**City:** Oakland, CA 94607**Report No:** WIR-024835**Date Inspected:** 23-Jun-2011**Project Name:** SAS Superstructure**OSM Arrival Time:** 700**Prime Contractor:** American Bridge/Fluor Enterprises, a JV**OSM Departure Time:** 1900**Contractor:** Zhenhua Port Machinery Company, Ltd (ZPMC) Chanxing Island**Location:** Shanghai, China**CWI Name:** Mr. Shi Lei**CWI Present:** Yes No**Inspected CWI report:** Yes No N/A**Rod Oven in Use:** Yes No N/A**Electrode to specification:** Yes No N/A**Weld Procedures Followed:** Yes No N/A**Qualified Welders:** Yes No N/A**Verified Joint Fit-up:** Yes No N/A**Approved Drawings:** Yes No N/A**Approved WPS:** Yes No N/A**Delayed / Cancelled:** Yes No N/A**Bridge No:** 34-0006**Component:** OBG Segment**Summary of Items Observed:**

WELDING INSPECTION REPORT

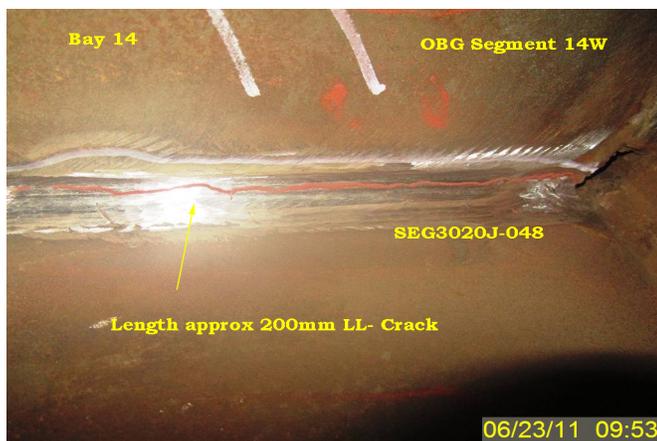
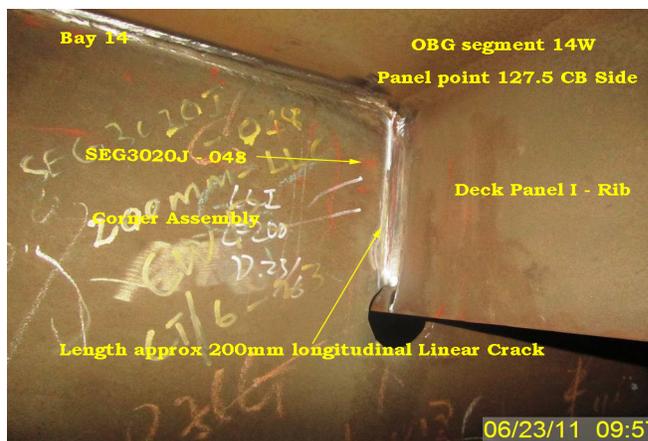
Description of Incident: During random Quality Assurance Visual review of welds located on segment 14W, this Quality Assurance Inspector (QA) discovered one (1) longitudinal linear indications measuring approximately 200mm in lengths. The indications were discovered visually and confirmed by Magnetic particle Testing (MT) by ABF and Caltrans QA. The indications are clearly marked on the material near the weld. The weld number is identified as SEG3020J-048. The panel point is identified as a PP127.5 cross beam side. This weld is a Fillet weld joining the Floor beam/corner assembly to deck panel I-rib. The Floor beam/corner assembly to deck panel I-rib weld is identified as Non SPCM. The ZPMC QC is identified as Mr. Zhu Lin. Caltrans QA requested to ZPMMC QC, perform the repair weld with comply proper documents. For further information, please see the attached pictures
