DEPARTMENT OF TRANSPORTATION

Contract #: 04-0120F4Cty: SF/ALA Rte: 80 PM: 13.2/13.9File #: 69.28**WELDING INSPECTION REPORT****Resident Engineer:** Siegenthaler, Peter**Address:** 333 Burma Road**City:** Oakland, CA 94607**Report No:** WIR-024852**Date Inspected:** 29-Jun-2011**Project Name:** SAS Superstructure**OSM Arrival Time:** 700**Prime Contractor:** American Bridge/Fluor Enterprises, a JV**OSM Departure Time:** 1900**Contractor:** Zhenhua Port Machinery Company, Ltd (ZPMC), Changxing Island **Location:** Shanghai, China

Visual Inspection after Blast

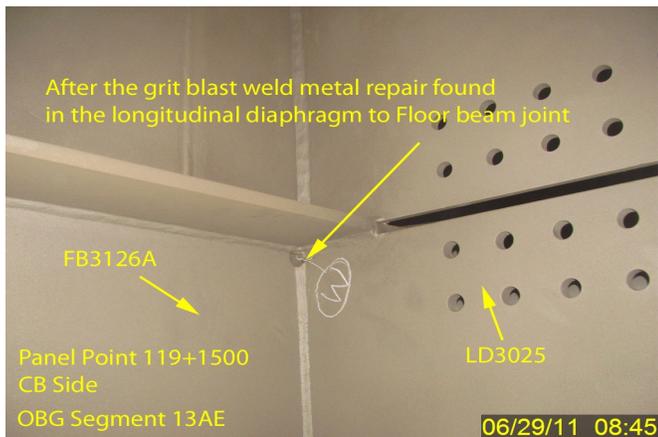
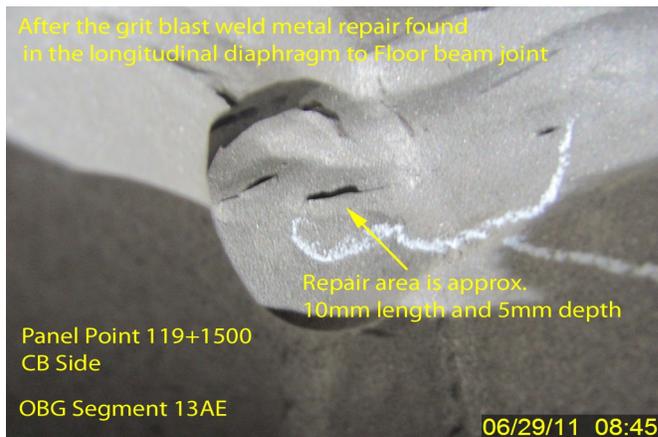
OBG Segment 13AE (PP119 to PP120):-

This QA Inspector performed a preliminary random visual inspection after the grit blast of the Interior components of the FL2 Deck panel "U" ribs, floor beam and longitudinal diaphragm of this segment. Areas of visual weld defects that will require welding were taped and will be repaired after the coating is applied. ZPMC QC personnel are aware of these areas and were present during the inspection. Please see the attached pictures.

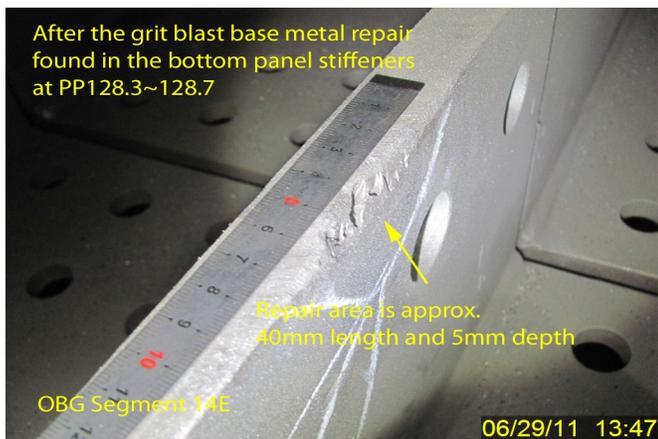
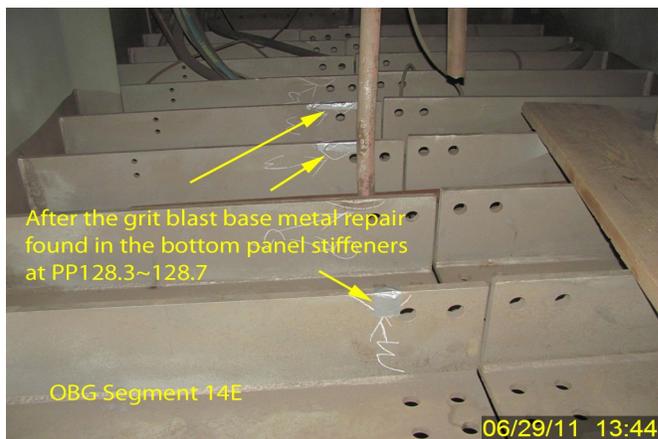
OBG Segment 14E (PP126 to PP128.7):-

This QA Inspector performed a preliminary random visual inspection after the grit blast of the Interior components of the FL2 Bottom panel stiffeners and Floor Beam of this segment. Areas of visual weld defects that will require welding were taped and will be repaired after the coating is applied. ZPMC QC personnel are aware of these areas and were present during the inspection. Please see the attached pictures.
