**DEPARTMENT OF TRANSPORTATION**

Contract #: 04-0120F4Cty: SF/ALA Rte: 80 PM: 13.2/13.9File #: 69.28**WELDING INSPECTION REPORT****Resident Engineer:** Siegenthaler, Peter**Address:** 333 Burma Road**City:** Oakland, CA 94607**Report No:** WIR-024903**Date Inspected:** 01-Jul-2011**Project Name:** SAS Superstructure**OSM Arrival Time:** 700**Prime Contractor:** American Bridge/Fluor Enterprises, a JV**OSM Departure Time:** 1900**Contractor:** Zhenhua Port Machinery Company, Ltd (ZPMC), Changxing Island **Location:** Shanghai, China**CWI Name:** An Qing Xiang**CWI Present:** Yes No**Inspected CWI report:** Yes No N/A**Rod Oven in Use:** Yes No N/A**Electrode to specification:** Yes No N/A**Weld Procedures Followed:** Yes No N/A**Qualified Welders:** Yes No N/A**Verified Joint Fit-up:** Yes No N/A**Approved Drawings:** Yes No N/A**Approved WPS:** Yes No N/A**Delayed / Cancelled:** Yes No N/A**Bridge No:** 34-0006**Component:** OBG**Summary of Items Observed:**

**BLAST SHOP 4, OBG 13CW**

**BLAST SHOP 2, OBG 14W**

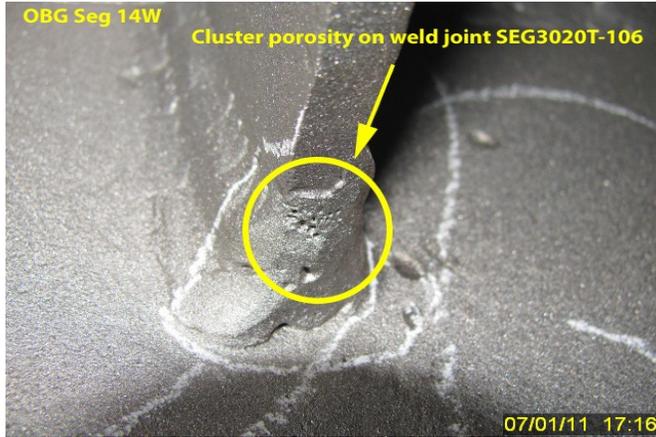
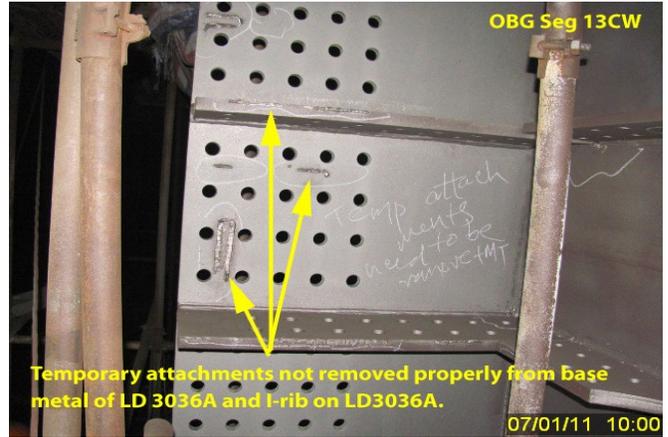
This QA Inspector performed Blast inspection on base metal, fillet welds and complete joint penetration (CJP) welds from panel point (PP) 122.5 to PP124.5 on internal surface of longitudinal diaphragm, floor beam and bottom panel of OBG segment 13CW at cable side section. During inspection, several non conforming discontinuities such as weld spatter, deep gouges, arc strikes and improper temporary attachment removal were observed. These areas were marked up for repair. All information regarding this marked on weld map and submitted to Lead QA Inspector. See attached photos for additional information.

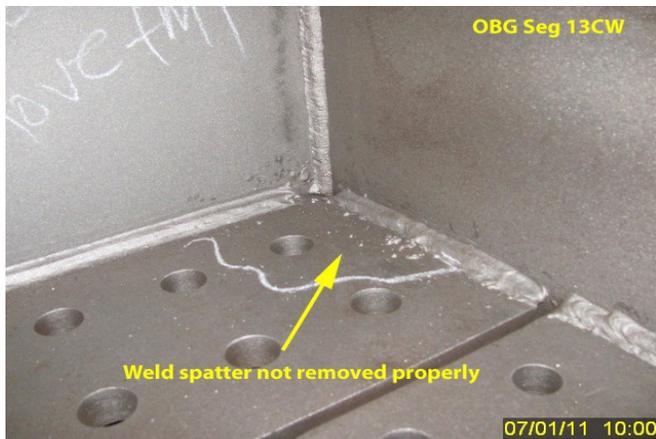
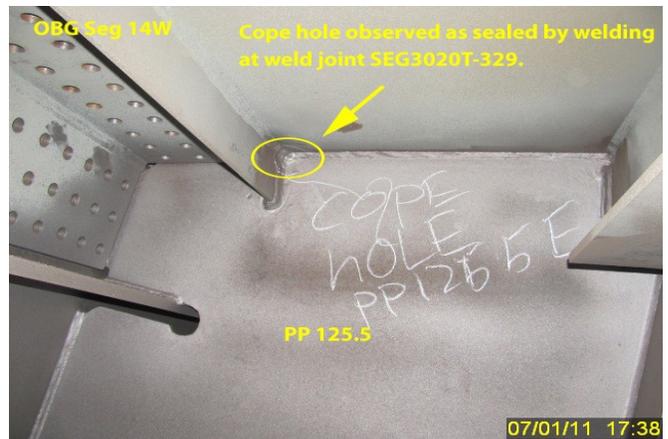
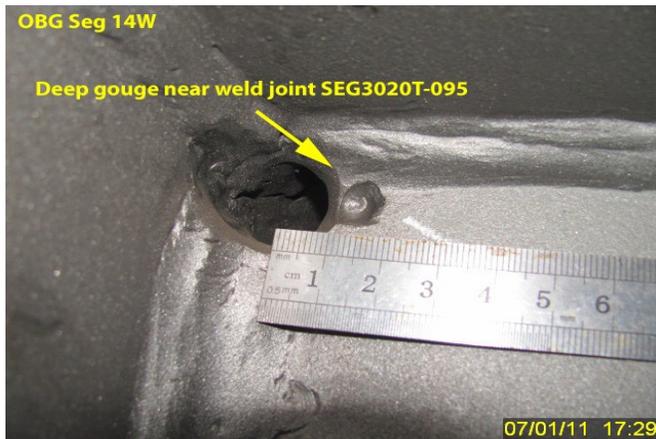
This QA Inspector performed Blast inspection on base metal, fillet welds and complete joint penetration (CJP) welds from panel point (PP) 125 to PP128.7 on internal surface of side panel, edge panel, floor beam, top anchorage plate and block out bottom plate of OBG segment 14W on at cross beam side. During inspection, several non conforming discontinuities such as weld spatter, deep gouges, arc strikes were, incomplete welds and improper cope hole profile observed. These areas were marked up for repair. All information regarding this

marked on weld map and submitted to Lead QA Inspector. See attached photos for additional information.
