DEPARTMENT OF TRANSPORTATION

Quality Assurance and Source Inspection

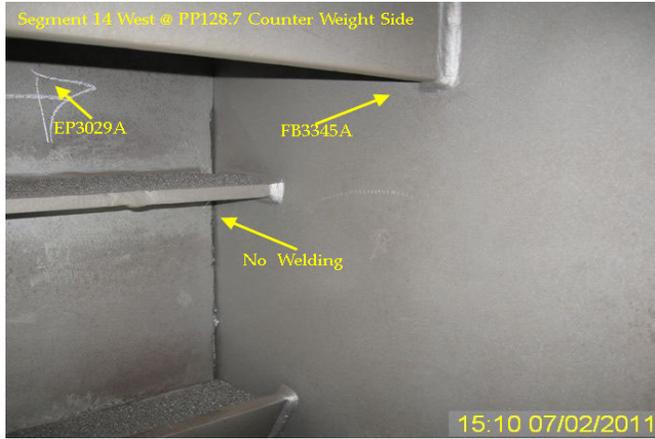
At PP128.7 (W) counter weight side, no welding on edge plate (EP3029A) to floor beam (FB3345A). See attached photo for further details.
