DEPARTMENT OF TRANSPORTATION

Quality Assurance and Source Inspection

Contract #: 04-0120F4Cty: SF/ALA Rte: 80 PM: 13.2/13.9File #: 1.28**WELDING INSPECTION REPORT****Resident Engineer:** Siegenthaler, Peter**Address:** 333 Burma Road**City:** Oakland, CA 94607**Report No:** WIR-024921**Date Inspected:** 29-Jun-2011**Project Name:** SAS Superstructure**OSM Arrival Time:** 700**Prime Contractor:** American Bridge/Fluor Enterprises, a JV**OSM Departure Time:** 1530**Contractor:** American Bridge/Fluor Enterprises, a JV**Location:** Jobsite**CWI Name:** As listed below**CWI Present:** Yes No**Inspected CWI report:** Yes No N/A**Rod Oven in Use:** Yes No N/A**Electrode to specification:** Yes No N/A**Weld Procedures Followed:** Yes No N/A**Qualified Welders:** Yes No N/A**Verified Joint Fit-up:** Yes No N/A**Approved Drawings:** Yes No N/A**Approved WPS:** Yes No N/A**Delayed / Cancelled:** Yes No N/A**Bridge No:** 34-0006**Component:** SAS OBG**Summary of Items Observed:**

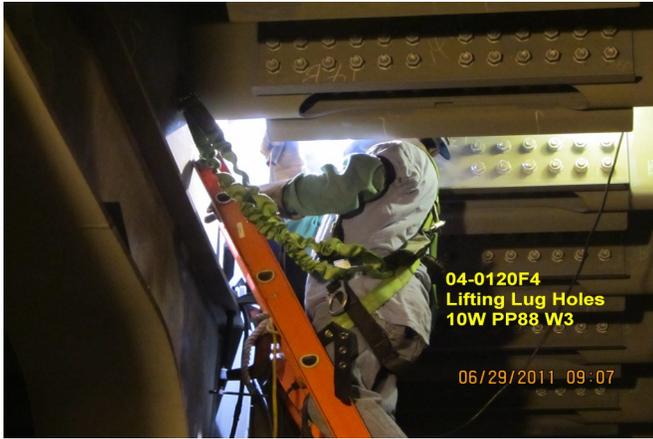
The QA Inspector made periodic observations of ABF welder Darcel Jackson ID# 9967 performing Shielded Metal Arc Welding (SMAW) in the 4G overhead position on Lifting Lug Hole (LLH) #4 located at 10W PP88 W3. The QA Inspector observed the QC Inspector Pat Swain as being present in order to monitor the progress and ensure the welding parameters were in compliance pertaining to ABF-WPS-D15-1110A Rev. 1. The QA Inspector observed the QC Inspector perform Magnetic Particle Testing (MT) on the completed welds and found them to be acceptable. The QA Inspector verified the testing and found it to be acceptable. The work was completed on this date and the QA Inspector noted that the work appeared to be in general conformance with the contract documents.
