**DEPARTMENT OF TRANSPORTATION**

Contract #: 04-0120F4Cty: SF/ALA Rte: 80 PM: 13.2/13.9File #: 1.28**WELDING INSPECTION REPORT****Resident Engineer:** Siegenthaler, Peter**Address:** 333 Burma Road**City:** Oakland, CA 94607**Report No:** WIR-024924**Date Inspected:** 01-Jul-2011**Project Name:** SAS Superstructure**OSM Arrival Time:** 700**Prime Contractor:** American Bridge/Fluor Enterprises, a JV**OSM Departure Time:** 1300**Contractor:** American Bridge/Fluor Enterprises, a JV**Location:** Jobsite

**Bridge No:** 34-0006**Component:** SAS OBG**Summary of Items Observed:**

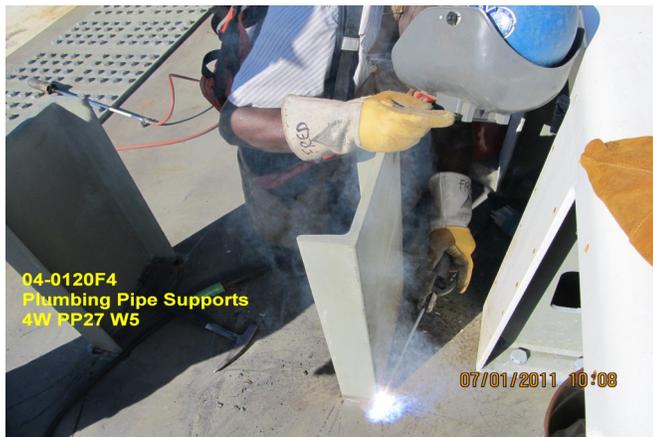
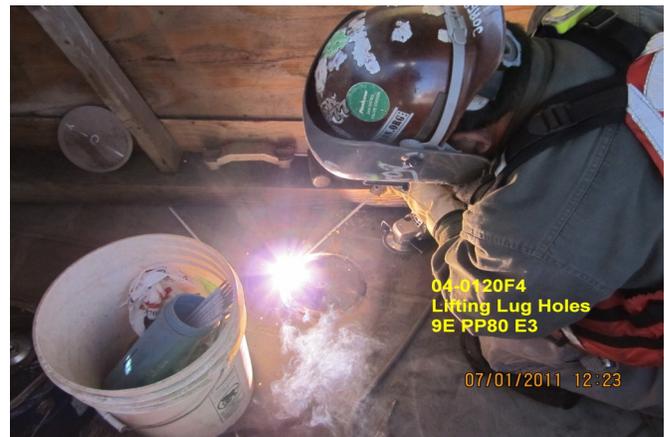
The QA Inspector performed a Magnetic Particle Test (MT) on Lifting Lug Hole (LLH) #2 at 10W PP88 W3. The QA Inspector tested 10% of the weld to verify the weld and testing by QC meet the requirements of the contract documents. The QA Inspector noted that the work appeared to be free of defects and was found to be acceptable and in general conformance with the contract documents. Upon completion of the MT, the QA Inspector performed Ultrasonic Testing utilizing a G.E./Krautkramer USN 60. The QA Inspector also utilized the UT Procedure identified as SE-UT-D1.5-CT-100 Rev.4 during the examination. Upon completion of the testing, it was noted by the QA Inspector that no indications were present and the work was found to be acceptable.

The QA Inspector made periodic observations of ABF welder Jorge Lopez ID# 6149 performing SMAW in the 1G flat position on LLH #3 located at 9E PP80 E3. The QA Inspector observed the fit up and found it to be acceptable. The QA Inspector observed the QC Inspector Pat Swain monitor the progress and ensure the welding parameters were in compliance pertaining to ABF-WPS-D15-1050A-CU. The work is in progress and the QA Inspector noted that the work appeared to be in general conformance with the contract documents.

The QA Inspector made periodic observations of ABF welder Fred Kaddu ID# 2188 performing SMAW in the 1G flat position on LLH #2 located at 9W PP80 W4. The QA Inspector observed the fit up and found it to be acceptable. The QA Inspector observed the QC Inspector Pat Swain monitor the progress and ensure the welding parameters were in compliance pertaining to ABF-WPS-D15-1050A-CU. The work is in progress and the QA Inspector noted that the work appeared to be in general conformance with the contract documents.

The QA Inspector made periodic observations of ABF welder Fred Kaddu ID# 2188 performing SMAW in the 1G flat position on C380 Channel for the Plumbing Pipe Supports located at 4W PP27 W. The QA Inspector observed the QC Inspector Pat Swain monitor the progress and ensure the welding parameters were in compliance pertaining to ABF-WPS-D15-F1200A Rev. 2. The work is in progress and the QA Inspector noted that the work appeared to be in general conformance with the contract documents.
