DEPARTMENT OF TRANSPORTATION

Quality Assurance and Source Inspection

Contract #: 04-0120F4Cty: SF/ALA Rte: 80 PM: 13.2/13.9File #: 69.28**WELDING INSPECTION REPORT****Resident Engineer:** Siegenthaler, Peter**Address:** 333 Burma Road**City:** Oakland, CA 94607**Report No:** WIR-024955**Date Inspected:** 17-May-2011**Project Name:** SAS Superstructure**OSM Arrival Time:** 700**Prime Contractor:** American Bridge/Fluor Enterprises, a JV**OSM Departure Time:** 1900**Contractor:** Zhenhua Port Machinery Company, Ltd (ZPMC), Changxing Island **Location:** Shanghai, China

WELDING INSPECTION REPORT

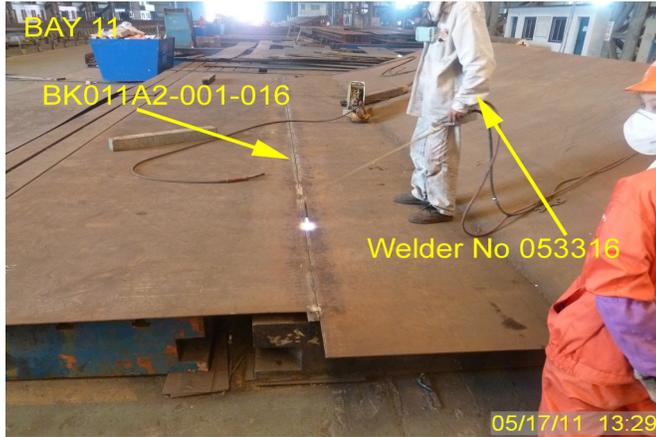
Unless otherwise noted, all work observed on this date appeared to generally comply with applicable contract documents.
