**DEPARTMENT OF TRANSPORTATION**

Contract #: 04-0120F4Cty: SF/ALA Rte: 80 PM: 13.2/13.9File #: 69.28**WELDING INSPECTION REPORT****Resident Engineer:** Siegenthaler, Peter**Address:** 333 Burma Road**City:** Oakland, CA 94607**Report No:** WIR-024978**Date Inspected:** 03-May-2011**Project Name:** SAS Superstructure**OSM Arrival Time:** 700**Prime Contractor:** American Bridge/Fluor Enterprises, a JV**OSM Departure Time:** 1900**Contractor:** Zhenhua Port Machinery Company, Ltd (ZPMC), Changxing Island **Location:** Shanghai, China**CWI Name:** Xu Le Feng**CWI Present:** Yes No**Inspected CWI report:** Yes No N/A**Rod Oven in Use:** Yes No N/A**Electrode to specification:** Yes No N/A**Weld Procedures Followed:** Yes No N/A**Qualified Welders:** Yes No N/A**Verified Joint Fit-up:** Yes No N/A**Approved Drawings:** Yes No N/A**Approved WPS:** Yes No N/A**Delayed / Cancelled:** Yes No N/A**Bridge No:** 34-0006**Component:** OBG & TOWER Components**Summary of Items Observed:**

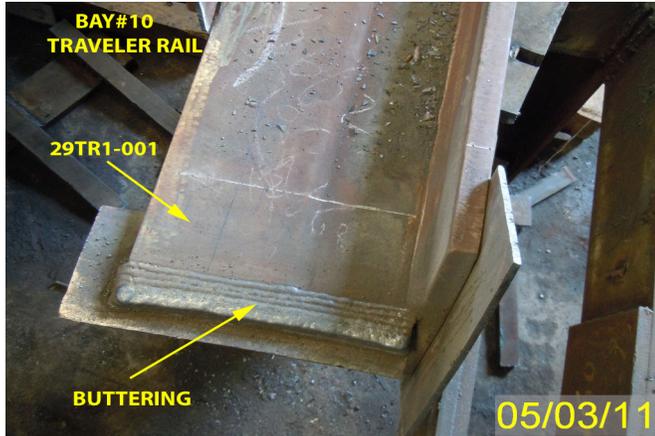
Surface welding / buttering being performed as per the critical weld repair report B-CWR16924 located on traveler rail identified as 29TR1-001. Welder is identified as 057266. ZPMC Quality Control (QC) Inspector is identified as Li Jun. The welding variables recorded by QC appeared to comply with the WPS – 345 – FCAW – 2G (2F) – ESAB – Repair. (See attached photo)

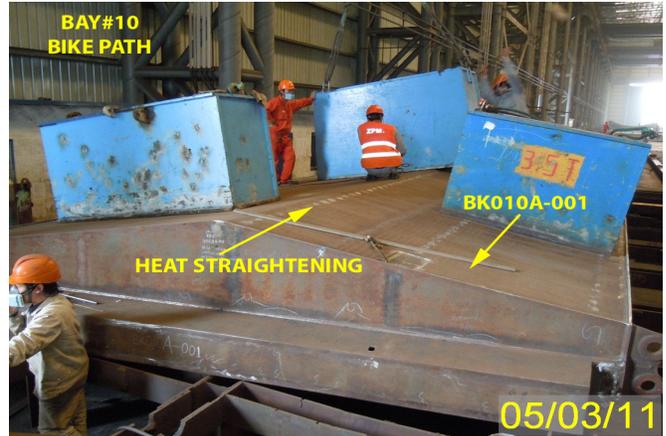
Heat Straightening being performed on Bike path identified as BK010A-001 by oxy-acetylene flame method to remove the distortion that occurred after welding. ZPMC Quality Control (QC) Inspector is identified as Li Jun present at the location. This activity appeared to comply with the Heat Straightening Report # HSR1 (B) – 10334. (See attached photo)
