Contract #: 04-0120F4Cty: SF/ALA Rte: 80 PM: 13.2/13.9File #: 69.28**WELDING INSPECTION REPORT****Resident Engineer:** Siegenthaler, Peter**Address:** 333 Burma Road**City:** Oakland, CA 94607**Report No:** WIR-025036**Date Inspected:** 26-May-2011**Project Name:** SAS Superstructure**OSM Arrival Time:** 1500**Prime Contractor:** American Bridge/Fluor Enterprises, a JV**OSM Departure Time:** 300**Contractor:** Zhenhua Port Machinery Company, Ltd (ZPMC), Changxing Island **Location:** Shanghai, China**CWI Name:** Mr. Lu Li Qing**CWI Present:** Yes No**Inspected CWI report:** Yes No N/A**Rod Oven in Use:** Yes No N/A**Electrode to specification:** Yes No N/A**Weld Procedures Followed:** Yes No N/A**Qualified Welders:** Yes No N/A**Verified Joint Fit-up:** Yes No N/A**Approved Drawings:** Yes No N/A**Approved WPS:** Yes No N/A**Delayed / Cancelled:** Yes No N/A**Bridge No:** 34-0006**Component:** OBG**Summary of Items Observed:**

OBG-Trial assembly Yard

Lift 13 East

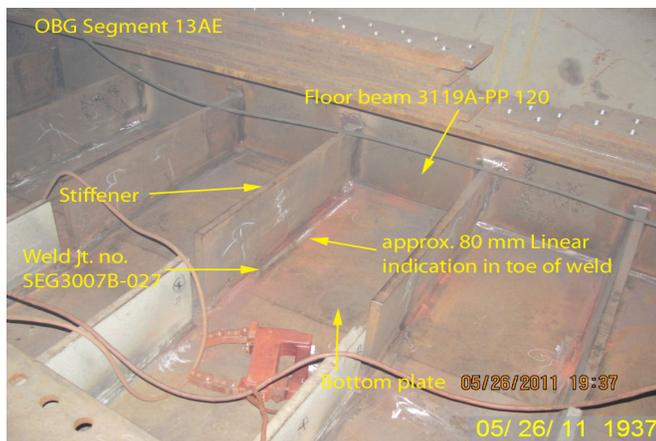
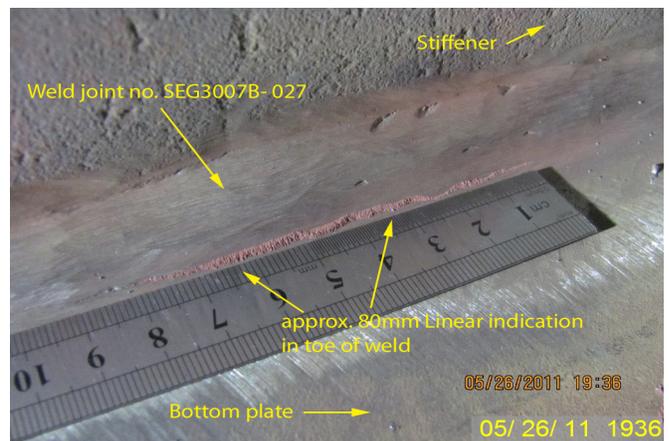
- One Longitudinal Linear indication measuring approximately 80 mm in length on Toe of weld.
- This indication found in weld joining Stiffener and bottom plate of Segment 13AE.
- The weld is identified as: SEG 3007B-027.
- This weld is a fillet weld joining Bottom plate and Stiffener.
- The “Y” location is approximately 300 mm from Floor beam 3119A, PP 120
- The bottom plate thickness is 100 mm and Stiffener thickness is 25mm.
- The Indication is clearly marked on the material near the weld.
- This Segment is located in OBG Trial assembly area.

This QA inspector, Baskar Govindarajan, performed Post blast inspection of external surfaces of Segment 13AE between PP 117.3 to 118. Due to Poor surface preparation, Water in corners, This QA Inspector observed, ABF Inspector Mr. Shi Stone rejected these surfaces.
