**DEPARTMENT OF TRANSPORTATION**

Contract #: 04-0120F4Cty: SF/ALA Rte: 80 PM: 13.2/13.9File #: 69.28**WELDING INSPECTION REPORT****Resident Engineer:** Siegenthaler, Peter**Address:** 333 Burma Road**City:** Oakland, CA 94607**Report No:** WIR-025066**Date Inspected:** 05-Jul-2011**Project Name:** SAS Superstructure**OSM Arrival Time:** 700**Prime Contractor:** American Bridge/Fluor Enterprises, a JV**OSM Departure Time:** 1900**Contractor:** Zhenhua Port Machinery Company, Ltd (ZPMC), Changxing Island **Location:** Shanghai, China**CWI Name:** An Qing Xiang**CWI Present:** Yes No**Inspected CWI report:** Yes No N/A**Rod Oven in Use:** Yes No N/A**Electrode to specification:** Yes No N/A**Weld Procedures Followed:** Yes No N/A**Qualified Welders:** Yes No N/A**Verified Joint Fit-up:** Yes No N/A**Approved Drawings:** Yes No N/A**Approved WPS:** Yes No N/A**Delayed / Cancelled:** Yes No N/A**Bridge No:** 34-0006**Component:** OBG**Summary of Items Observed:**

**BLAST SHOP 2, OBG 14W**

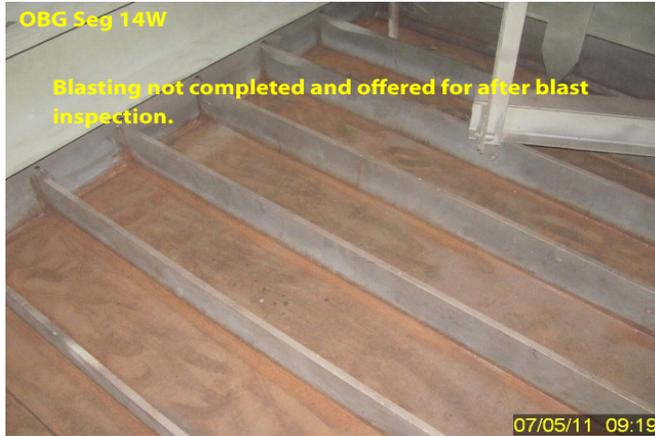
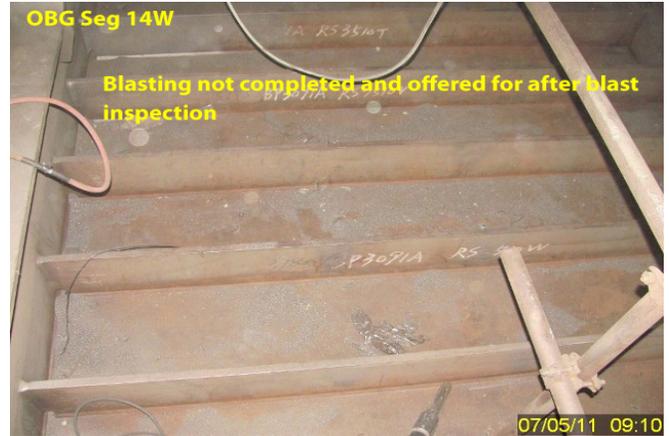
After blast inspection was offered (by ZPMC / ABF) for internal surfaces of Bottom Panel of FL2 area of Seg 14W. However, this QA Inspector observed that the blasting itself was not yet completed. This was then informed to CT Lead QA. No further inspection was then carried out. See attached photos for additional information.
