**DEPARTMENT OF TRANSPORTATION**

Contract #: 04-0120F4Cty: SF/ALA Rte: 80 PM: 13.2/13.9File #: 1.28**WELDING INSPECTION REPORT****Resident Engineer:** Siegenthaler, Peter**Address:** 333 Burma Road**City:** Oakland, CA 94607**Report No:** WIR-025076**Date Inspected:** 07-Jul-2011**Project Name:** SAS Superstructure**OSM Arrival Time:** 700**Prime Contractor:** American Bridge/Fluor Enterprises, a JV**OSM Departure Time:** 1530**Contractor:** American Bridge/Fluor Enterprises, a JV**Location:** Job Site**CWI Name:** Steve Jensen**CWI Present:** Yes No**Inspected CWI report:** Yes No N/A**Rod Oven in Use:** Yes No N/A**Electrode to specification:** Yes No N/A**Weld Procedures Followed:** Yes No N/A**Qualified Welders:** Yes No N/A**Verified Joint Fit-up:** Yes No N/A**Approved Drawings:** Yes No N/A**Approved WPS:** Yes No N/A**Delayed / Cancelled:** Yes No N/A**Bridge No:** 34-0006**Component:** Tower**Summary of Items Observed:**

114 Meter elevation – East Tower – Splice Plates

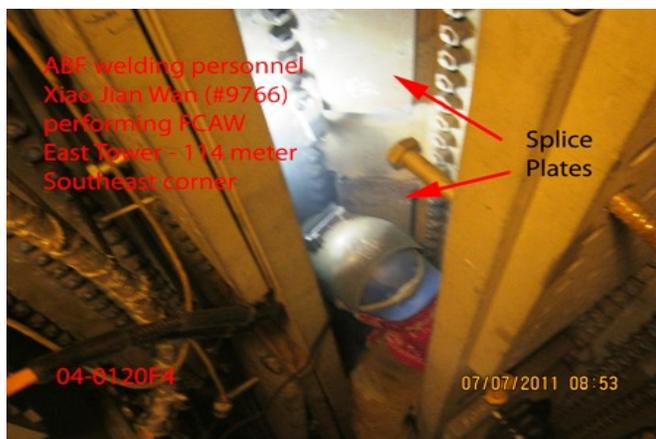
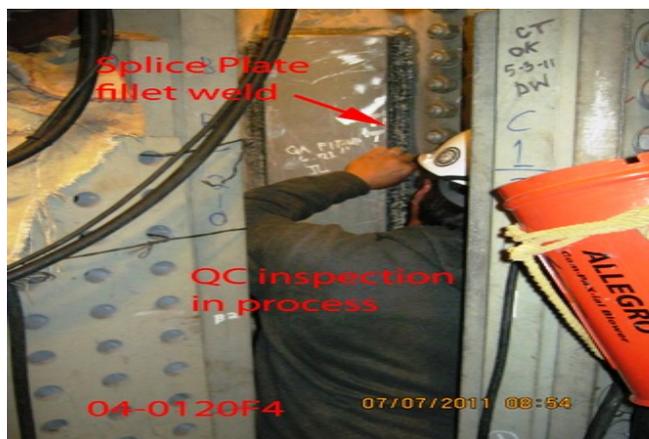
This QA Inspector observed ABF welding personnel Salvador Sandoval (#2202) using the Flux Cored Arc Welding (FCAW) process for production welding in the vertical (3F) position on weld joint #165-East. This QA Inspector randomly observed as QC Inspector Steve Jensen verified the following parameters; 272 amperes and 21.5 volts at a travel speed of 100 mm per minute to produce a heat input value of 3.51 Kj per mm. The welding observed by this QA Inspector appeared to comply with the Welding Procedure Specification (WPS) ABF-WPS-D15-F2200-3. This QA Inspector observed the FCAW welding was completed and the only welding that remained for this weld joint was the overhead fillet weld which required the use of the Shielded Metal Arc Welding (SMAW) process. This QA Inspector randomly observed ABF welding personnel Salvador Sandoval

(#2202) using the SMAW process for production welding on the overhead (4F) fillet weld. This QA Inspector observed QC Inspector Steve Jensen verify the following parameters; 185 amperes using a 4.0 mm diameter E7018H4R electrode. The welding appeared to comply with ABF-WPS-D15-F1200. Later this shift this QA Inspector was present when QC Inspector Steve Jensen performed a visual inspection on weld joints #165-East and #166-East. This QA Inspector observed several areas were marked for additional welding and grinding; see photo below. QC Inspector Steve Jensen informed this QA Inspector later that the welding and grinding had been completed, the areas re-inspected and that he had accepted weld joints #165-East and #166-East. This QA Inspector performed a random visual verification and observed the work appeared to comply with the contract requirements.

This QA Inspector observed ABF welding personnel Xiao Jian Wan (#9677) using the FCAW process for production welding in the vertical (3F) position on the top half of weld joint #165-Southeast. This QA Inspector randomly observed as QC Inspector Steve Jensen verified the following parameters; 245 amperes and 20.5 volts at a travel speed of 95 mm per minute to produce a heat input value of 3.17 Kj per mm. The welding observed appeared to comply with ABF-WPS-D15-F2200-3. See photo below noting the confined space which limits overall movement. This QA Inspector observed as QC Inspector Steve Jensen performed a visual inspection on weld joint #166-Southeast and mark several areas for grinding. This QA Inspector randomly observed as this grinding was performed by ABF welding personnel Xiao Jian Wan (#9677) and the areas re-inspected by QC Inspector Steve Jensen who informed this QA Inspector he had accepted the weld. This QA Inspector performed a random visual verification of weld joint #166-Southeast and observed the work appeared to comply with the contract requirements.
