Contract #: 04-0120F4Cty: SF/ALA Rte: 80 PM: 13.2/13.9File #: 1.28**WELDING INSPECTION REPORT****Resident Engineer:** Siegenthaler, Peter**Address:** 333 Burma Road**City:** Oakland, CA 94607**Report No:** WIR-025078**Date Inspected:** 09-Jul-2011**Project Name:** SAS Superstructure**OSM Arrival Time:** 700**Prime Contractor:** American Bridge/Fluor Enterprises, a JV**OSM Departure Time:** 1530**Contractor:** American Bridge/Fluor Enterprises, a JV**Location:** Job Site

Caltrans Office of Structural Material (OSM) Quality Assurance Inspector (QAI) Joselito Lizardo was present at the Self Anchored Suspension (SAS) job site as requested to perform observations on the welding of components for the San Francisco Oakland Bay Bridge (SFOBB) Project.

At Tower Base Elevation 13Meters Shear Plate Electro Slag Welding (ESW);

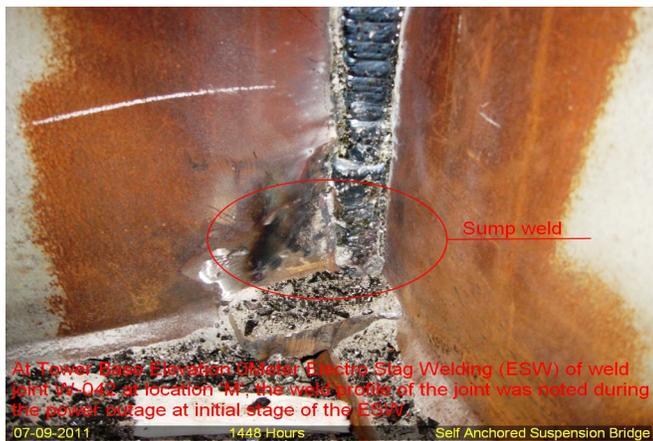
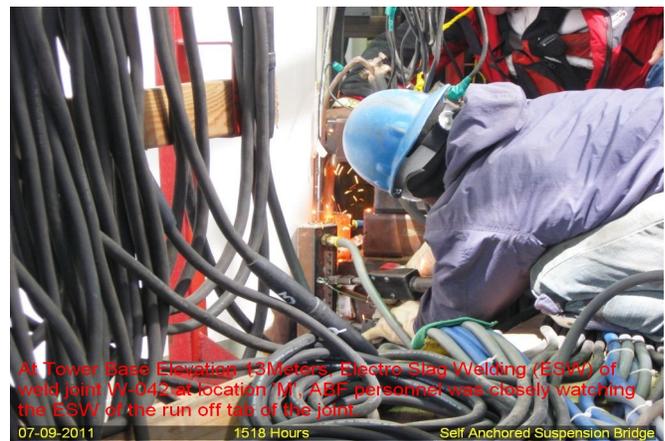
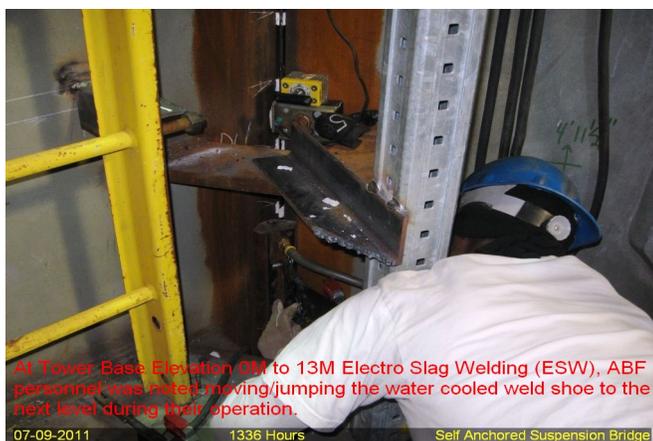
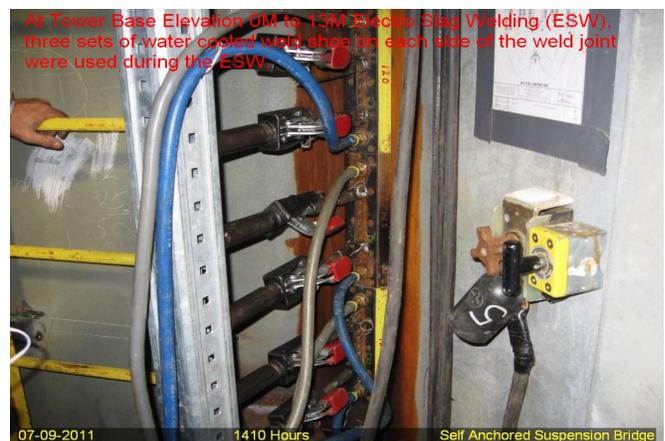
This QA was present at the Tower Base to observe the Electro Slag Welding of the weld number W-042 located at 'M' position per ABF weld map. The weld joint to be welded is a 60mm shear plate to Tower West Shaft skin plate (70mm) 'A', T-joint located at the corner of Tower West shaft skin plates 'A' and 'B'. ABF intends to implement Caltrans approved welding procedure ABF-WPS-ESW-150T in performing the ESW.

Upon QA's arrival, ABF personnel were noted preparing to weld the shear plate butt joint by checking all the necessary electrical and water hose weld shoe cooling connections are all in place prior to commence ESW. It was noted that three weld shoes were in position at each opposing side of the joint and so with the consumable guide tube that was placed in between the joint gap which was separated by consumable ceramic insulators. Other ABF personnel that were noted assisting the preparation of the ESW include ABF Production Manager John Callaghan and ABF Engineer Daniel Hester.

The fit up alignment was previously checked by ABF QC Jesse Cayabyab and this QA. The root gap was measured from bottom to top and the result noted was 17mm minimum and 23mm maximum which deemed in compliance to the WPS.

Initial firing of the ESW has started at 1059 hours but just barely one minute welding the power went down again but recovered few seconds later and continued until the completion of the joint at around 1514 hours. During the course of the ESW, this QA went down to the bottom of the weld sump and checked the status of the weld that was performed during the power outage. It appeared that the ESW was still at the weld sump when the power outage has occurred.
