DEPARTMENT OF TRANSPORTATION

Contract #: 04-0120F4Cty: SF/ALA Rte: 80 PM: 13.2/13.9File #: 99.28**WELDING INSPECTION REPORT****Resident Engineer:** Siegenthaler, Peter**Address:** 333 Burma Road**City:** Oakland, CA 94607**Report No:** WIR-025143**Date Inspected:** 09-Jul-2011**Project Name:** SAS Superstructure**OSM Arrival Time:** 700**Prime Contractor:** American Bridge/Fluor Enterprises, a JV**OSM Departure Time:** 1900**Contractor:** Zhenhua Port Machinery Company, Ltd (ZPMC), Changxing Island **Location:** Shanghai**CWI Name:****CWI Present:**

Bridge No: 34-0006**Component:** OBG**Summary of Items Observed:**

Trial Assembly 13E

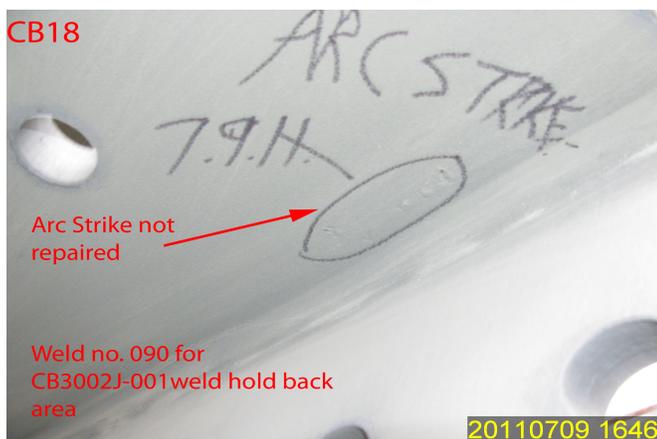
West side plate – Porosity at rib stiffener fillet welds 090 & 092 on weld map CB3002J-001, 6th and 7th rib stiffeners from bottom plate. These welds were not repaired at this time and still require repair and re-inspection.

Deck plate – Porosity at rib stiffener fillet welds 110 & 116 on weld map CB3002J-001, 3rd and 6th rib stiffeners from Side plate. These welds were not repaired at this time and still require repair and re-inspection.

West side plate- Arc Strike at weld 089 on weld map CB3002J-001, 6th rib stiffener from bottom plate. Arc strike was discovered, this arc strike must be repaired and re-inspected by Magnetic Particle testing (MT).
