**DEPARTMENT OF TRANSPORTATION**

Contract #: 04-0120F4Cty: SF/ALA Rte: 80 PM: 13.2/13.9File #: 69.28**WELDING INSPECTION REPORT****Resident Engineer:** Siegenthaler, Peter**Address:** 333 Burma Road**City:** Oakland, CA 94607**Report No:** WIR-025174**Date Inspected:** 03-Jul-2011**Project Name:** SAS Superstructure**OSM Arrival Time:** 1900**Prime Contractor:** American Bridge/Fluor Enterprises, a JV**OSM Departure Time:** 700**Contractor:** Zhenhua Port Machinery Company, Ltd (ZPMC), Changxing Island **Location:** Shanghai, China**CWI Name:** See Below**CWI Present:** Yes No**Inspected CWI report:** Yes No N/A**Rod Oven in Use:** Yes No N/A**Electrode to specification:** Yes No N/A**Weld Procedures Followed:** Yes No N/A**Qualified Welders:** Yes No N/A**Verified Joint Fit-up:** Yes No N/A**Approved Drawings:** Yes No N/A**Approved WPS:** Yes No N/A**Delayed / Cancelled:** Yes No N/A**Bridge No:** 34-0006**Component:** OBG**Summary of Items Observed:**

# WELDING INSPECTION REPORT

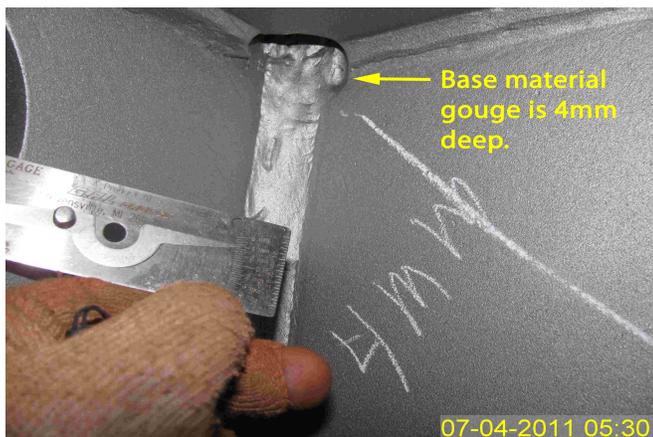
Blast bay #2, OBG segments 14W

ZPMC requested Caltrans personnel to perform visual inspections of OBG segment 14W vertical plates located between PP125 and the anchor plate following the initial pre-blast cleaning of the steel surfaces. This QA Inspector along with two other QA Inspectors performed random visual inspections of these areas and observed multiple areas that require grinding to remove arc strikes, sharp edges, minor gouges and two areas that require weld repairs. Caltrans QA Inspectors' provided the locations of these weld repairs to dayshift QA personnel for adding this information to the 14W tracking database. See the photograph below for additional information.
