**DEPARTMENT OF TRANSPORTATION**

Contract #: 04-0120F4Cty: SF/ALA Rte: 80 PM: 13.2/13.9File #: 1.28**WELDING INSPECTION REPORT****Resident Engineer:** Siegenthaler, Peter**Address:** 333 Burma Road**City:** Oakland, CA 94607**Report No:** WIR-025185**Date Inspected:** 14-Jul-2011**Project Name:** SAS Superstructure**OSM Arrival Time:** 700**Prime Contractor:** American Bridge/Fluor Enterprises, a JV**OSM Departure Time:** 1730**Contractor:** American Bridge/Fluor Enterprises, a JV**Location:** Job Site

<b>CWI Name:</b>	Steve Jensen and Mike Johnson			<b>CWI Present:</b>	<b>Yes</b>	<b>No</b>	
<b>Inspected CWI report:</b>	<b>Yes</b>	<b>No</b>	<b>N/A</b>	<b>Rod Oven in Use:</b>	<b>Yes</b>	<b>No</b>	<b>N/A</b>
<b>Electrode to specification:</b>	<b>Yes</b>	<b>No</b>	<b>N/A</b>	<b>Weld Procedures Followed:</b>	<b>Yes</b>	<b>No</b>	<b>N/A</b>
<b>Qualified Welders:</b>	<b>Yes</b>	<b>No</b>	<b>N/A</b>	<b>Verified Joint Fit-up:</b>	<b>Yes</b>	<b>No</b>	<b>N/A</b>
<b>Approved Drawings:</b>	<b>Yes</b>	<b>No</b>	<b>N/A</b>	<b>Approved WPS:</b>	<b>Yes</b>	<b>No</b>	<b>N/A</b>
				<b>Delayed / Cancelled:</b>	<b>Yes</b>	<b>No</b>	<b>N/A</b>
<b>Bridge No:</b>	34-0006			<b>Component:</b>	SAS Tower

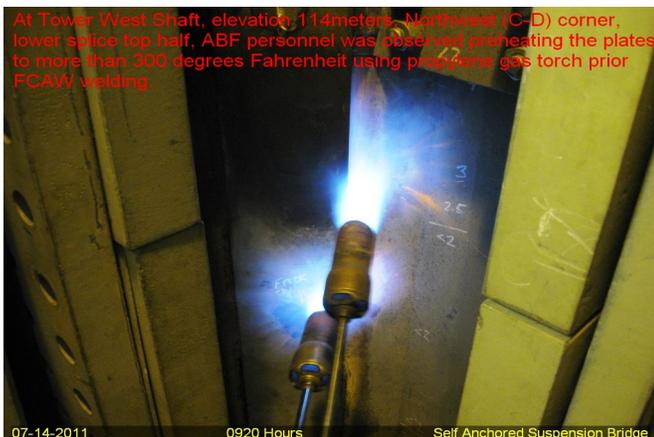
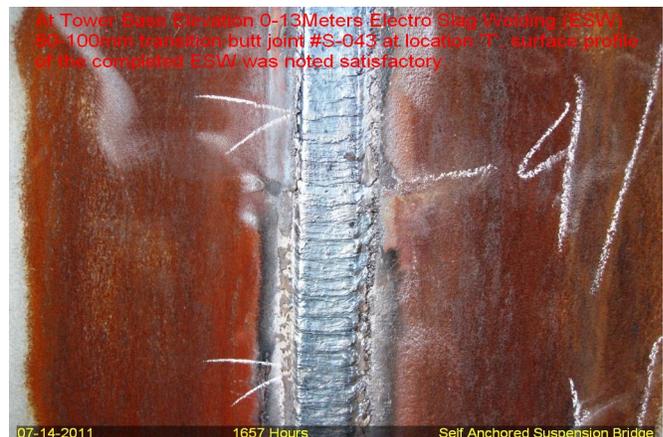
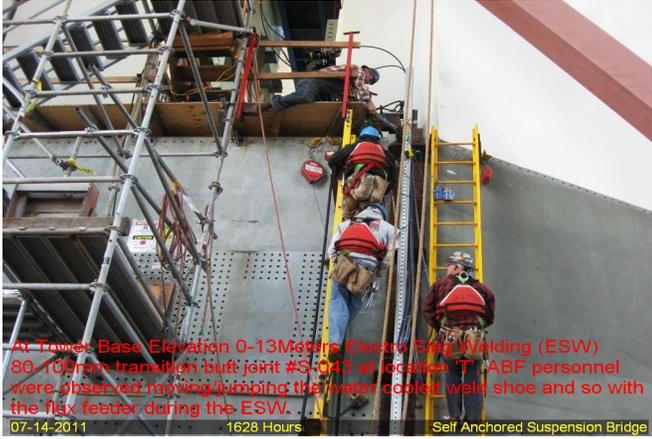
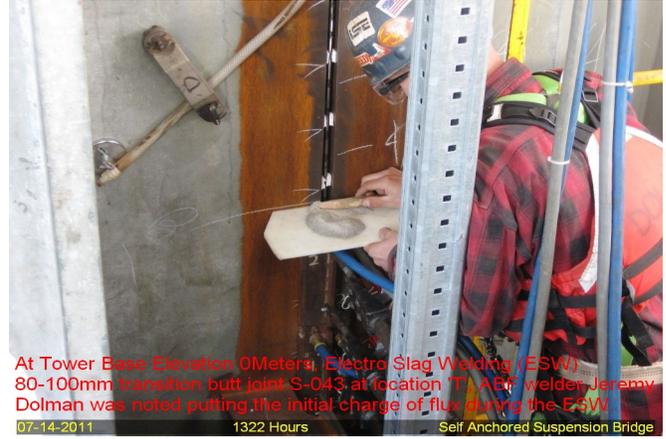
At Tower Base Elevation 13Meters Shear Plate Electro Slag Welding (ESW);

This QA was present at the Tower Base to observe the Electro Slag Welding of the weld number S-043 located at

'T' position per ABF weld map. The weld joint to be welded is an 80-100mm transition butt at corner 'B' and 'C' of Tower South Shaft. ABF intends to implement Caltrans approved welding procedure ABF-WPS-ESW-80-100TR in performing the ESW.

The fit up alignment was previously checked by ABF QC Jesse Cayabyab and this QA. The root gap was measured from bottom to top and the result noted was 16mm minimum and 25mm maximum which deemed in compliance to the WPS. The offset exceeded the maximum allowed on various locations from 4mm to 9mm and this was brought to ABF and Caltrans for review.

Initial firing of the ESW has started at 1312 hours but this was considered false start due to one filler wire was not moving and got stuck somewhere inside the consumable guide tube. ABF personnel momentarily stopped the operation and fixed the filler wire issue. After fixing and checking the filler wire, ABF has re-started the ESW at 1317hours. This time, the firing of the ESW was successful and that both filler wires were moving and the welding parameters have stabilized. The ESW has continued without a hitch until the completion of the joint at around 1738 hours for a total of four (4) hours and twenty one (21) minutes welding time. Overall, the ESW was completed without any major issues during the operation and the surface profile of the completed transition butt joint appears satisfactory.
