**DEPARTMENT OF TRANSPORTATION**

Contract #: 04-0120F4Cty: SF/ALA Rte: 80 PM: 13.2/13.9File #: 1.28**WELDING INSPECTION REPORT****Resident Engineer:** Siegenthaler, Peter**Address:** 333 Burma Road**City:** Oakland, CA 94607**Report No:** WIR-025219**Date Inspected:** 16-Jul-2011**Project Name:** SAS Superstructure**OSM Arrival Time:** 700**Prime Contractor:** American Bridge/Fluor Enterprises, a JV**OSM Departure Time:** 1530**Contractor:** American Bridge/Fluor Enterprises, a JV**Location:** Jobsite**CWI Name:** William Sherwood**CWI Present:** Yes No**Inspected CWI report:** Yes No N/A**Rod Oven in Use:** Yes No N/A**Electrode to specification:** Yes No N/A**Weld Procedures Followed:** Yes No N/A**Qualified Welders:** Yes No N/A**Verified Joint Fit-up:** Yes No N/A**Approved Drawings:** Yes No N/A**Approved WPS:** Yes No N/A**Delayed / Cancelled:** Yes No N/A**Bridge No:** 34-0006**Component:** SAS OBG**Summary of Items Observed:**

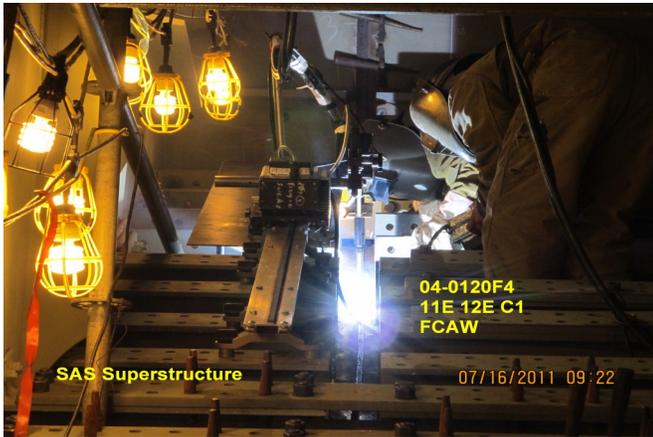
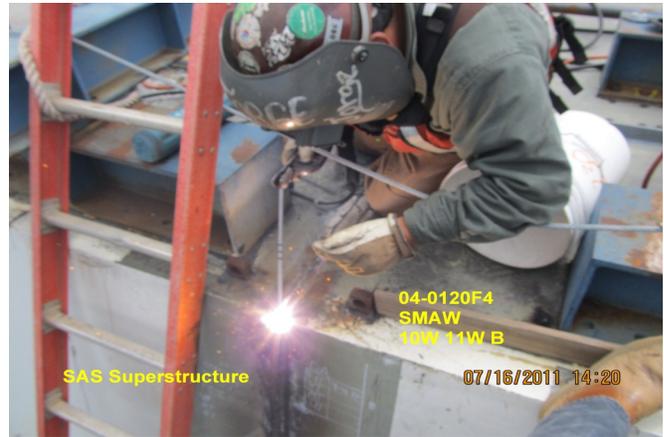
The QA Inspector randomly observed ABF welding operators Wai Kitlai ID#2953 performing Flux Core Arc Welding w/gas (FCAW-G) operations in the 3G vertical position on side plate C at 11E 12E on the inside of the OBG. The QA Inspector observed the QC Inspector Pat Swain as being present in order to monitor the progress and ensure the welding parameters were in compliance pertaining to ABF-WPS-D15-3042B-1. The QA Inspector noted that the work appears to be in general conformance with the contract documents.

The QA Inspector observed ABF welder Jorge Lopez ID# perform SMAW in the 3G vertical position on edge plate B at 11W 12W outside of the OBG. The QA Inspector observed the QC Inspector identified as Steve Jensen as being present in order to monitor the progress and ensure the welding parameters were in compliance pertaining

to ABF-WPS-D15-1040A Rev. 1. The QA Inspector noted that the work is in progress and appeared to be in general conformance with the contract documents.

The QA Inspector performed straight beam Ultrasonic Testing on two random lifting lugs in each segment at 7E PP52 E4 #1 & 3, 8E PP67 E3 #2 & 4, 9E PP76 E4 #1 & 3 and 10E PP88 E3 #2 & 4. The testing appeared to be free of indications and was found to be acceptable. The scan was performed in the defined UT area on drawings ZPM-04-01-001216 to ZPM-04-01-001219 where accessible. The work is in progress and appeared to be in general conformance with submittal 1635 Rev.00.
