DEPARTMENT OF TRANSPORTATION

Quality Assurance and Source Inspection

Tower Shear Plates – Electro Slag Welding (ESW) – weld number N-041:

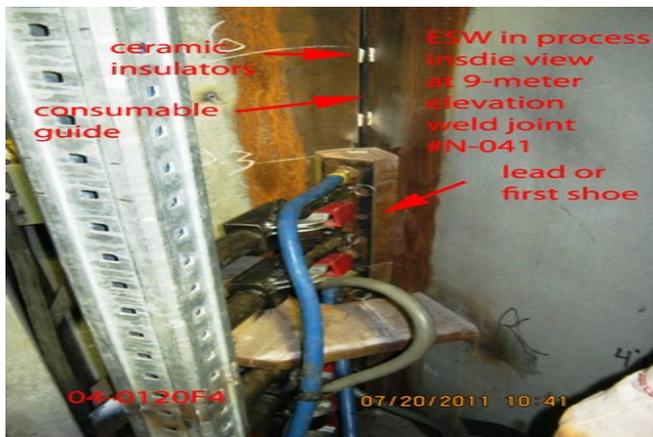
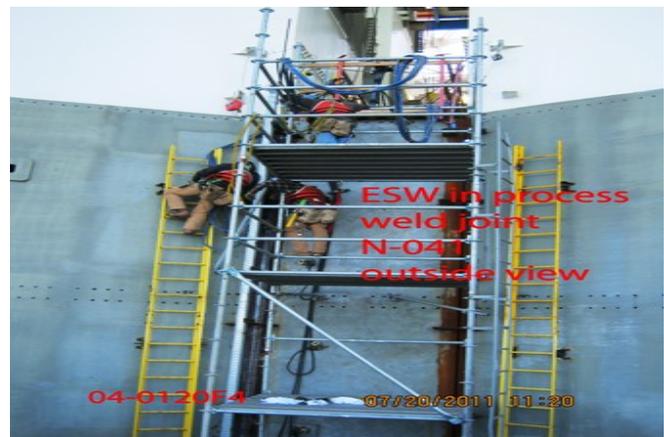
At approximately 1205 hours this date ESW was completed for weld joint number N-041. This QA Inspector had monitored the ESW from various locations and did not observe or hear any indications other than what was noted above that would indicate welding from the normal. See photos below of ESW in process.
