DEPARTMENT OF TRANSPORTATION

Contract #: 04-0120F4Cty: SF/ALA Rte: 80 PM: 13.2/13.9File #: 1.28**WELDING INSPECTION REPORT****Resident Engineer:** Siegenthaler, Peter**Address:** 333 Burma Road**City:** Oakland, CA 94607**Report No:** WIR-025278**Date Inspected:** 22-Jul-2011**Project Name:** SAS Superstructure**OSM Arrival Time:** 700**Prime Contractor:** American Bridge/Fluor Enterprises, a JV**OSM Departure Time:** 1930**Contractor:** American Bridge/Fluor Enterprises, a JV**Location:** Job Site

WELDING INSPECTION REPORT

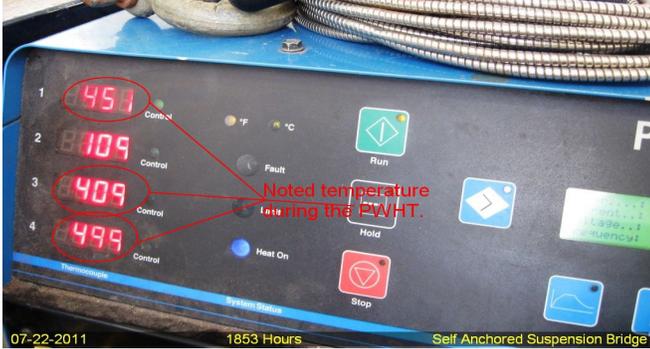
At the Tower Base Electro Slag Welding (ESW) of T-joint W-041 location ‘W’, this QA was instructed to observe the Post Weld Heat Treatment (PWHT) of the mentioned weld joint due to welding incident that occurred. Two water hoses for the water cooled weld shoes got leaked and partially splashed to the weld joint being welded causing steam reaction to the area. To neutralize the effect of the water splashing into the weld, Caltrans Senior Engineer Marc Woods recommended to perform the PWHT right after the ESW welding completion.

ABF personnel prepared the heater blankets for the inside and outside. ABF also cut strong back from inside and outside to have access for the heater blankets. It was around 1530hours when they completed preparation for the PWHT and started ramping up the temperature. At around 1545hours, one of the hose line for the Miller Proheat 35 Induction Heating System got popped up and squirted the liquid from the hose to the plate causing another steam reaction. The PWHT Heating Machine shut off immediately.

ABF personnel removed all the heater blankets from the inside and outside and prepared a new set up of blankets for the PWHT. It took longer than expected the new preparation for the PWHT. At around 1830hours when they completed the set up for the PWHT and during this time ABF personnel was noted programming the machine to ramp up the heat to 690°F per hour with soak temperature of 435°F and soak time of six (6) hours. The PWHT went well this time and at around 1900hours the temperature was already noted 451°F. Per suggestion from Caltrans, QA does not need to watch the complete duration of the PWHT. At 1930hours, this QA informed Caltrans Engineer Mr. Doug Wright that QA was leaving and informed him about the PWHT was ongoing. ABF Sr. Field Engineer Daniel Hester and ABF Production Manager John Callaghan were noted watching the ongoing PWHT.

At Tower Base Electro Slag Welding (ESW) of T-joint W-041 at location 'W', ABF personnel were noted using the Tower Probeat 55 Induction Heating System in performing the Post Weld Heat Treatment on the ESW welded T-joint.

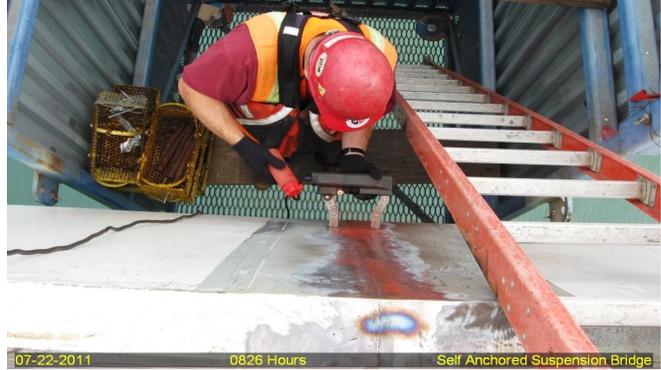
At OBG 11W/12W edge plate 'B' outside, ABF QC John Pagliaro was observed performing Magnetic Particle Testing (MT) on welded splice butt joint.

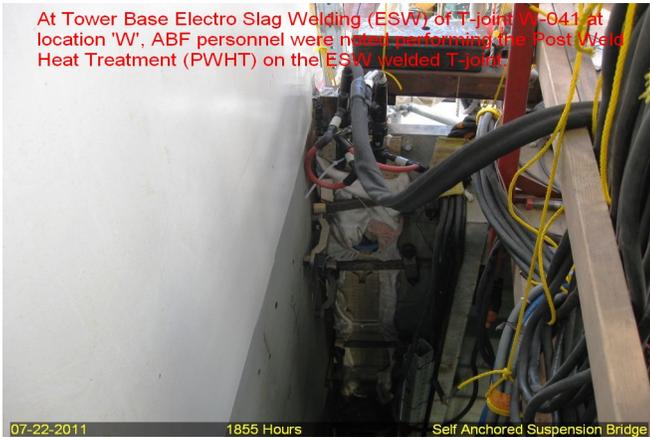
At Tower Base Electro Slag Welding (ESW) of T-joint W-041 at location 'W', ABF personnel were noted performing the Post Weld Heat Treatment (PWHT) on the ESW welded T-joint.

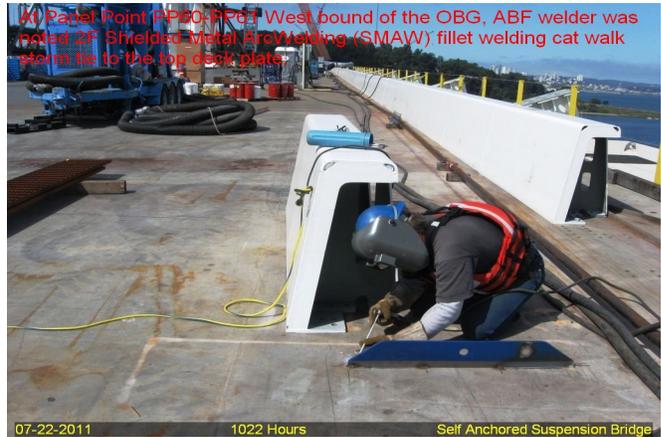
At the West bound side of the OBG, ABF welders Erick Sparks was noted 2F fillet welding on the cat walk storm tie at various locations. Welder Erick Sparks was noted utilizing Shielded Metal Arc Welding (SMAW) with 1/8” electrode implementing Caltrans approved (WPS) ABF-WPS-D15-F1200A. During the shift and welding, ABF QC Fred Von Hoff was noted monitoring the parameters of the welder. At the end of the shift, fillet welding of 6mm x 300mm long on both sides of the plate welded to the top of deck plate was completed at the following locations;

At Paper Point (PP00/PP01) West bound of the OBG, ABF welder was noted 2F Shielded Metal ArcWelding (SMAW) fillet welding cat walk storm tie to the top deck plate.
