**DEPARTMENT OF TRANSPORTATION**

Contract #: 04-0120F4Cty: SF/ALA Rte: 80 PM: 13.2/13.9File #: 1.28**WELDING INSPECTION REPORT****Resident Engineer:** Siegenthaler, Peter**Address:** 333 Burma Road**City:** Oakland, CA 94607**Report No:** WIR-025280**Date Inspected:** 23-Jul-2011**Project Name:** SAS Superstructure**OSM Arrival Time:** 700**Prime Contractor:** American Bridge/Fluor Enterprises, a JV**OSM Departure Time:** 1530**Contractor:** American Bridge/Fluor Enterprises, a JV**Location:** Job Site**CWI Name:** John Pagliero**CWI Present:** Yes No**Inspected CWI report:** Yes No N/A**Rod Oven in Use:** Yes No N/A**Electrode to specification:** Yes No N/A**Weld Procedures Followed:** Yes No N/A**Qualified Welders:** Yes No N/A**Verified Joint Fit-up:** Yes No N/A**Approved Drawings:** Yes No N/A**Approved WPS:** Yes No N/A**Delayed / Cancelled:** Yes No N/A**Bridge No:** 34-0006**Component:** SAS Tower**Summary of Items Observed:**

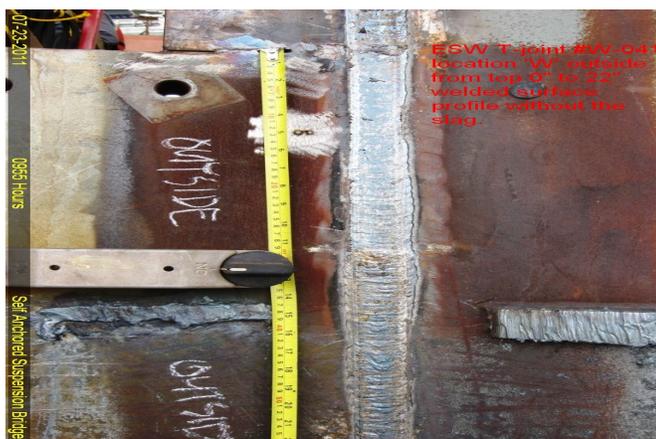
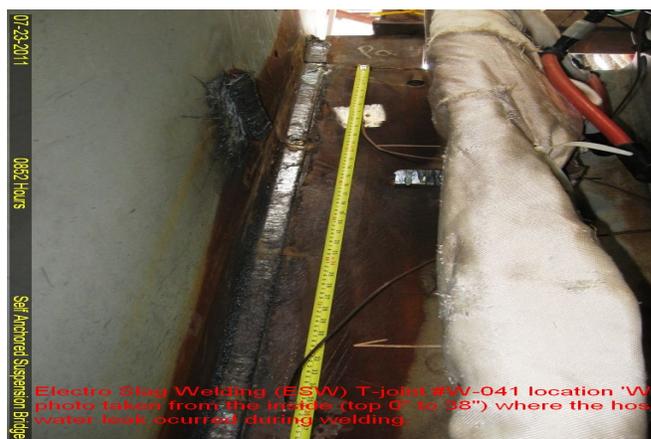
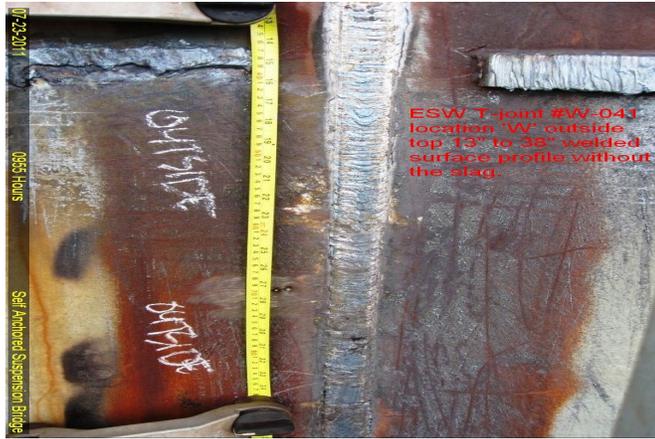
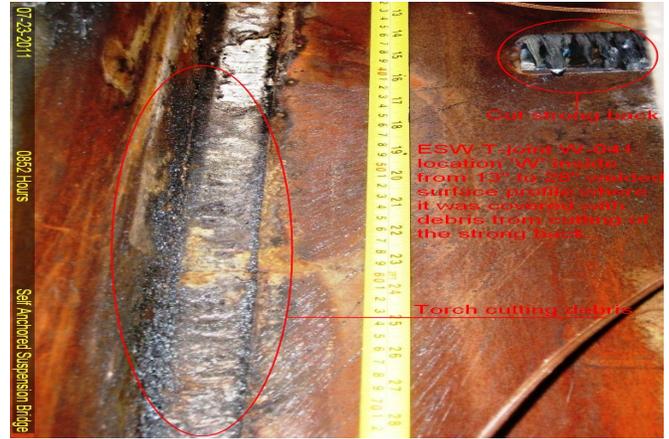
10. This QA performed a random visual review on the completed ESW joint particularly on the areas where the hose where water leakage had occurred and noted a normal weld surface profile of the weld without any indication of blemishes or anomalies to the weld.

13. Attached digital photographs were taken after the PWHT and these showed the weld surface profile from the inside and outside of the weld joint. More emphasis were taken at the top of the weld joint where the water leakage had occurred during ESW welding.
