DEPARTMENT OF TRANSPORTATION

Office of Structural Materials

Contract #: 04-0120F4Cty: SF/ALA Rte: 80 PM: 13.2/13.9File #: 69.28**WELDING INSPECTION REPORT****Resident Engineer:** Siegenthaler, Peter**Address:** 333 Burma Road**City:** Oakland, CA 94607**Report No:** WIR-025306**Date Inspected:** 08-Jul-2011**Project Name:** SAS Superstructure**OSM Arrival Time:** 700**Prime Contractor:** American Bridge/Fluor Enterprises, a JV**OSM Departure Time:** 1900**Contractor:** Zhenhua Port Machinery Corporation, Ltd (ZPMC), Changxing Island **Location:** Shanghai, China**CWI Name:** Mr. Mai Quin Li**CWI Present:** Yes No**Inspected CWI report:** Yes No N/A**Rod Oven in Use:** Yes No N/A**Electrode to specification:** Yes No N/A**Weld Procedures Followed:** Yes No N/A**Qualified Welders:** Yes No N/A**Verified Joint Fit-up:** Yes No N/A**Approved Drawings:** Yes No N/A**Approved WPS:** Yes No N/A**Delayed / Cancelled:** Yes No N/A**Bridge No:** 34-0006**Component:** Bike Path Components**Summary of Items Observed:**

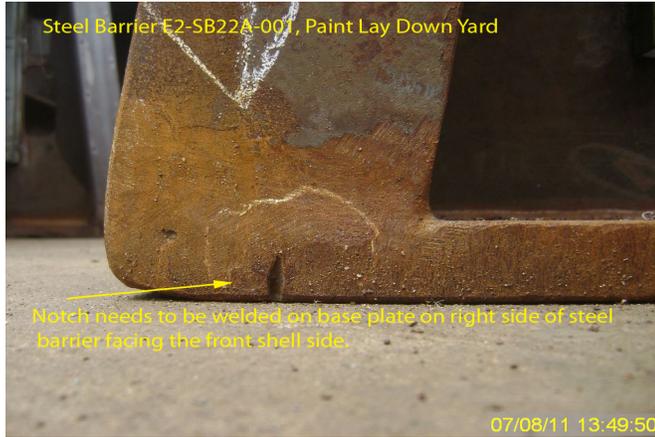
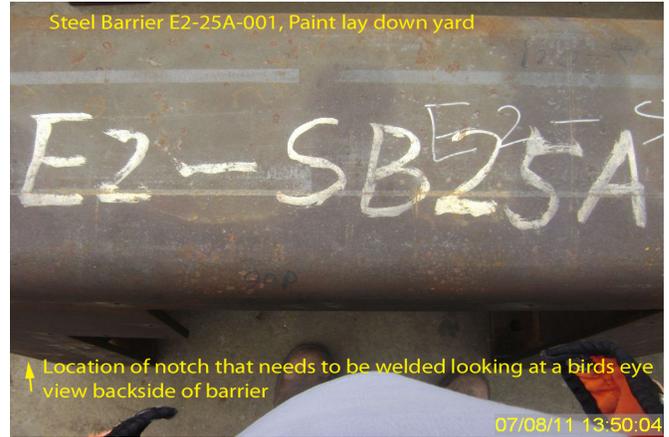
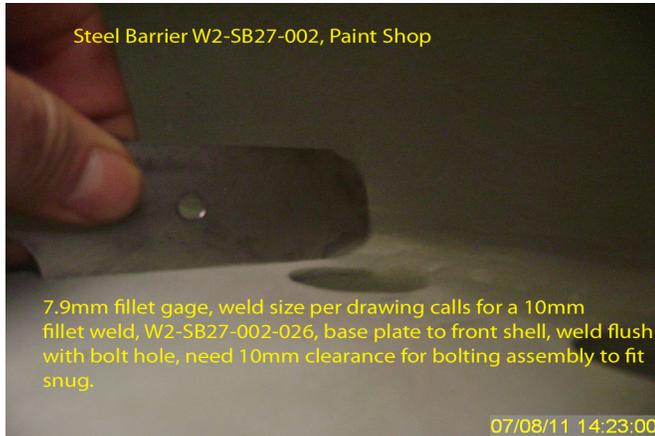
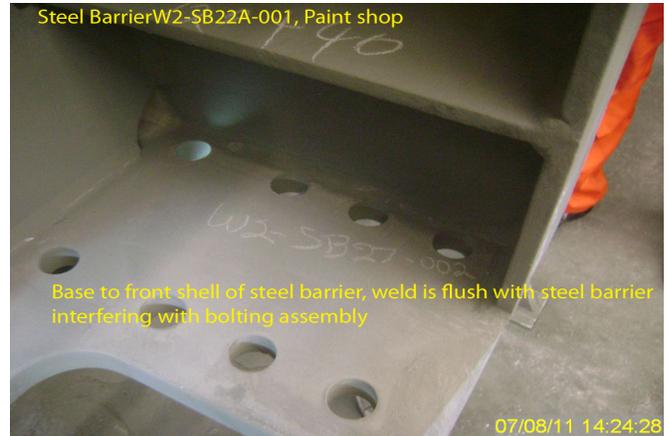
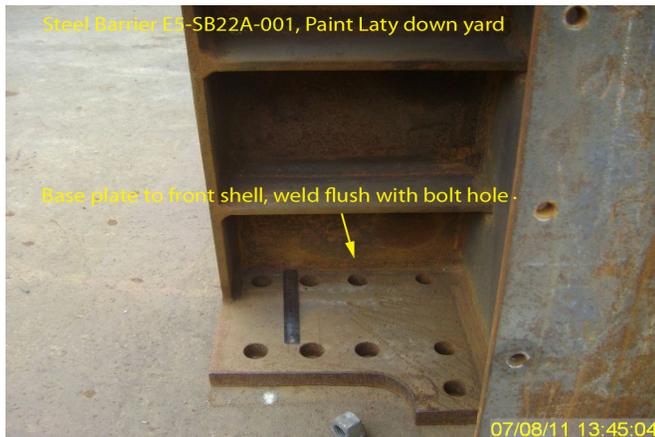
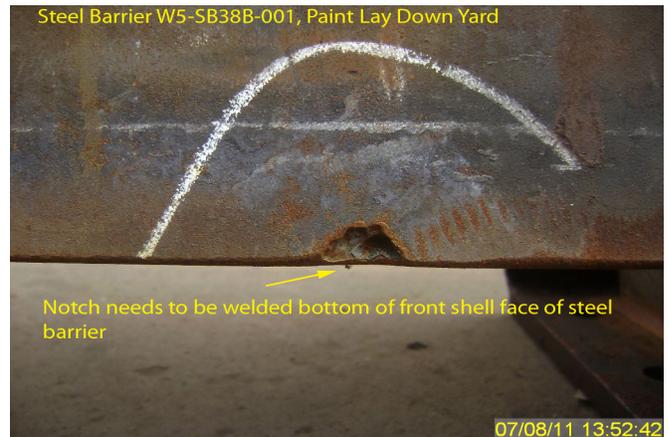
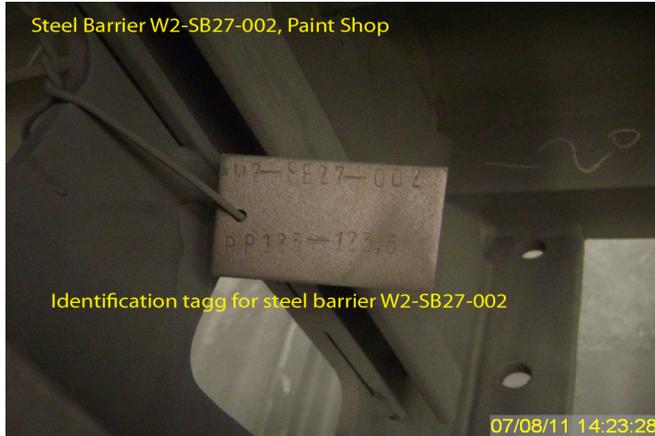
Upon request by Caltran Quality Assurance(QA)Paint Inspector. This Quality Assurance(QA) found steel barrier E5-SB22A-001 to have insufficient welds in weld area 026 and welds to close to bolt holes causing interference with bolting assembly. In formed ABF Quality Control Mr. Gao Zhen Kun. Location is at Paint Yard in front of Bay 2.

Upon request by Caltran Quality Assurance(QA) Paint Inspector. This Quality Assurance(QA) found steel barriers E2-SB25A-001 to have a notch in the side of base plate approximately 5mm in depth. In formed ABF Quality Control Mr. Gao Zhen Kun. Location is at Paint Yard in front of Bay 2.

Upon request by Caltran Quality Assurance(QA) Paint Inspector. This Quality Assurance(QA) found steel barriers W5-SB38BA-001 to have a notch in the front shell, part #w5-p-68, approximately 6mm in depth. In formed ABF Quality Control Mr. Gao Zhen Kun. Location is at Paint Yard in front of Bay 2.

Upon request by Caltran Quality Assurance(QA)Paint Inspector. This Quality Assurance(QA) found steel barrier W2-SB27-001 to have insufficient welds in weld area 026 and welds to close to bolt holes causing interference with bolting assembly. In formed ABF Quality Control Mr. Gao Zhen Kun. Location is at Paint Yard in front of Bay 2.

Description of Incident: During the Quality Assurance (QA) random visual inspection of OBG Steel Barriers, W2-SB27-002-026 & E5-SB22A-001-026 in front of Paint Shop #2, this QA Inspector discovered the following issues:

- Tack welds not incorporated into the final weld need to be removed on BKPL82A.
- The fillet weld horizontal leg extended to the edge of the bolt hole causing interference with the bolting assembly.

- A total of 12 bolt holes on 3 bottom base plates to front shell of steel barriers are affected.
