DEPARTMENT OF TRANSPORTATION

Contract #: 04-0120F4Cty: SF/ALA Rte: 80 PM: 13.2/13.9File #: 1.28**WELDING INSPECTION REPORT****Resident Engineer:** Siegenthaler, Peter**Address:** 333 Burma Road**City:** Oakland, CA 94607**Report No:** WIR-025343**Date Inspected:** 22-Jul-2011**Project Name:** SAS Superstructure**OSM Arrival Time:** 700**Prime Contractor:** American Bridge/Fluor Enterprises, a JV**OSM Departure Time:** 1530**Contractor:** American Bridge/Fluor Enterprises, a JV**Location:** Job Site**CWI Name:** Steve McConnell**CWI Present:** Yes No**Inspected CWI report:** Yes No N/A**Rod Oven in Use:** Yes No N/A**Electrode to specification:** Yes No N/A**Weld Procedures Followed:** Yes No N/A**Qualified Welders:** Yes No N/A**Verified Joint Fit-up:** Yes No N/A**Approved Drawings:** Yes No N/A**Approved WPS:** Yes No N/A**Delayed / Cancelled:** Yes No N/A**Bridge No:** 34-0006**Component:** OBG Sections**Summary of Items Observed:**

Tower Shear Plates – Electro Slag Welding (ESW) – weld number W-041:

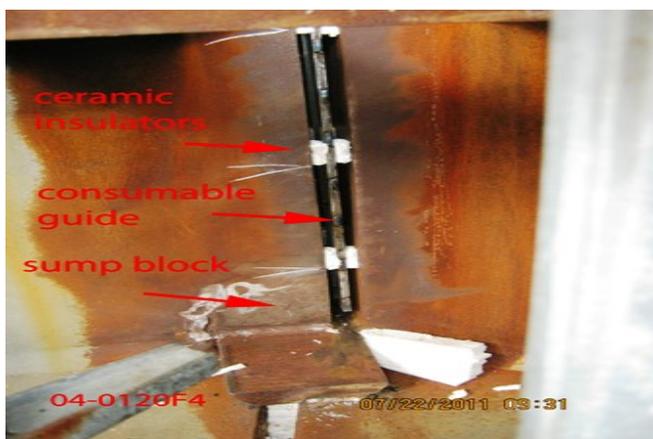
Prior to the start of ESW this date this QA Inspector observed the following; the bottom slump plate and top run off tabs were welded into position, the consumable guide was centered in the weld joint and held into position with ceramic insulators approximately 150 mm apart (one on each side of the guide). See photo below of bottom section of weld joint. This QA Inspector was informed by QC Inspector Steve McConnell that he had performed the QC check off list with ABF welding personnel Danny Ieraci (#3232) and that all item appeared to comply with the contract requirements. This QA Inspector had been previously informed by QA Inspector Jojo Lizardo that he had performed the verification of the weld joint fit up including the root opening and offset.

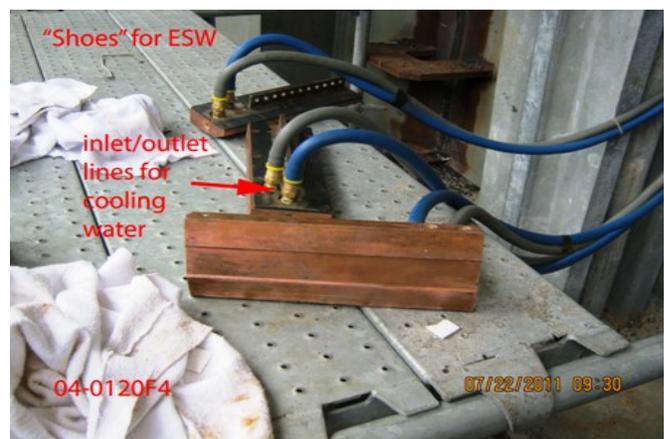
1425 hours – This QA Inspector was located at the 3 meter elevation outside the towers and observed what appeared to be several clouds of steam rising into the air above the ESW joint. This QA Inspector proceeded to the inside location at the 9 meter elevation. This QA Inspector observed various ABF personnel rushing to and from the ESW location. This QA Inspector went around the ESW location to the South in order to prevent impeding any movement of ABF personnel. This QA Inspector arrived inside the North Tower and observed through the access man way that water was spraying profusely from several of the cooling lines and that the water lines were not attached to the welding shoes. This QA Inspector observed water was running down the East side of the North Tower adjacent to the weld joint and that water was reaching the hot weld joint due to the amount of steam and hissing sounds. This QA Inspector observed multiple ABF welding personnel on the access ladders working to control the situation. This QA Inspector observed that welding had not been stopped and that it appeared the weld pool was approximately 1200 mm for the top of the shear plate at this time. This QA Inspector observed that was approximately 1-2 inches (25 -50 mm) of water running across the 9 meter elevation diaphragm plates.

1446 hours – This QA Inspector observed the ESW weld had been completed. Prior to the completion of the welding this QA Inspector observed one more of the welding shoes had been jumped to complete the welding. Shortly after the completion of welding the water supply was shut off and this QA Inspector observed what appeared to be two disconnected cooling lines.

This QA Inspector had taken several photos during the quenching of the weld in an effort to capture a cloud of steam, but unfortunately none of the photos produced the intended results. See photo below of a typical ESW shoe to note where and how the cooling lines are attached. The cooling lines are attached by sliding the hose over a fitting by hand a mechanical fastener, such as a clamp is not used.

This QA Inspector had observed Caltrans Engineer Doug Wright was also present and verbally informed him of the temperature readings noted above. Caltrans Engineer Doug Wright informed this QA Inspector he had contacted Caltrans Engineer Mark Woods regarding the loss of cooling water and the water quenching of the weld as noted above and had been informed that ABF may want to proceed with the Post Weld Heat Treatment (PWHT) of this weld as soon as possible.
