DEPARTMENT OF TRANSPORTATION

Contract #: 04-0120F4Cty: SF/ALA Rte: 80 PM: 13.2/13.9File #: 1.28**WELDING INSPECTION REPORT****Resident Engineer:** Siegenthaler, Peter**Address:** 333 Burma Road**City:** Oakland, CA 94607**Report No:** WIR-025344**Date Inspected:** 25-Jul-2011**Project Name:** SAS Superstructure**OSM Arrival Time:** 700**Prime Contractor:** American Bridge/Fluor Enterprises, a JV**OSM Departure Time:** 1530**Contractor:** American Bridge/Fluor Enterprises, a JV**Location:** Jobsite**CWI Name:** William Sherwood**CWI Present:** Yes No**Inspected CWI report:** Yes No N/A**Rod Oven in Use:** Yes No N/A**Electrode to specification:** Yes No N/A**Weld Procedures Followed:** Yes No N/A**Qualified Welders:** Yes No N/A**Verified Joint Fit-up:** Yes No N/A**Approved Drawings:** Yes No N/A**Approved WPS:** Yes No N/A**Delayed / Cancelled:** Yes No N/A**Bridge No:** 34-0006**Component:** SAS OBG**Summary of Items Observed:**

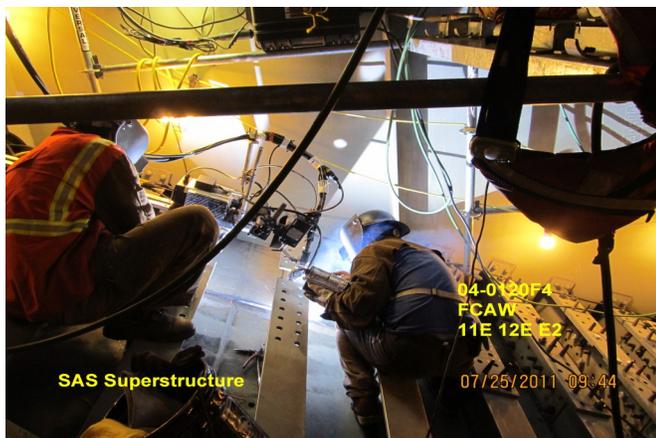
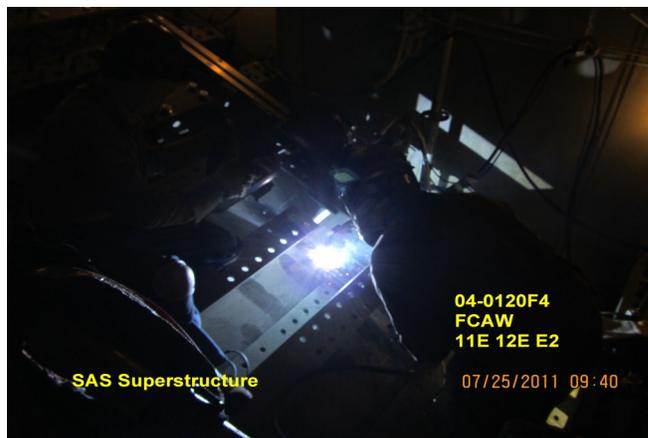
1. 11E 12E Side Plate E1 (Interior)
2. 11E 12E Edge Plate B (Interior)
3. 11E 12E Side Plate E2 (Interior)
4. 11E 12E Edge Plate F (Interior)
